The Examination and Treatment of an American Gilded Girandole, ca. 1830

Arlen Heginbotham

ABSTRACT: An American gilded girandole convex mirror, dating to approximately 1830, was examined and treated in the Philadelphia Museum of Art's furniture conservation laboratory. The girandole frame, gilded in contrasting matte oil and burnished water gilding, was in unusually well-preserved condition, although it was very dirty, had been liberally restored with bronze paint, and suffered several areas of substantial loss.

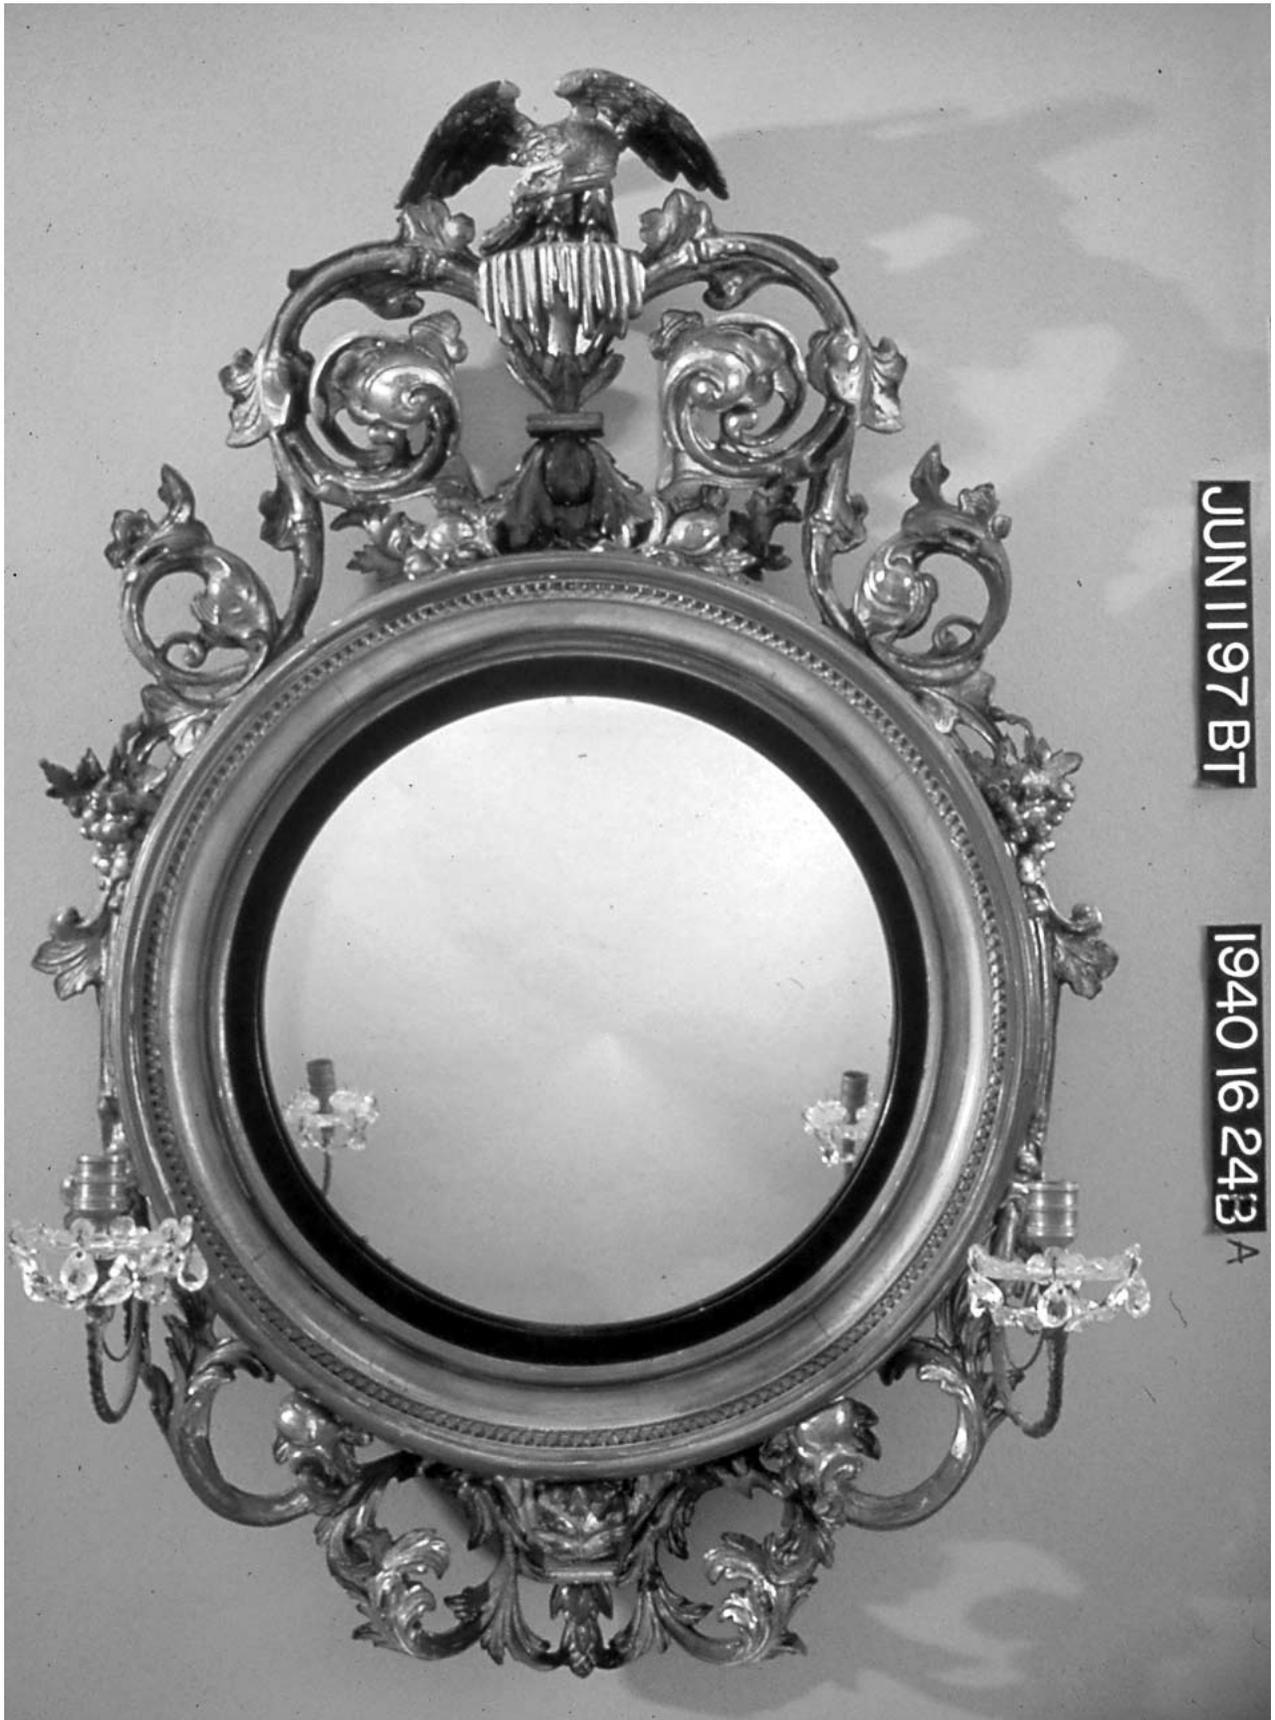
Figure 1: The girandole before treatment.

In general, the girandole was in good condition. There was a significant accumulation of dirt and soil on the surface, and in a few localized areas, the gilding exhibited some minor flaking. The girandole had been liberally restored with bronze paint, which had since darkened considerably and was quite disfiguring. There were several areas of substantial loss, including a large acanthus leaf element just above the molded wooden frame at the center; a large section of the twist decoration on the proper left candle arm; and the total loss of the gilded balls and chain which would originally have hung on the frame.

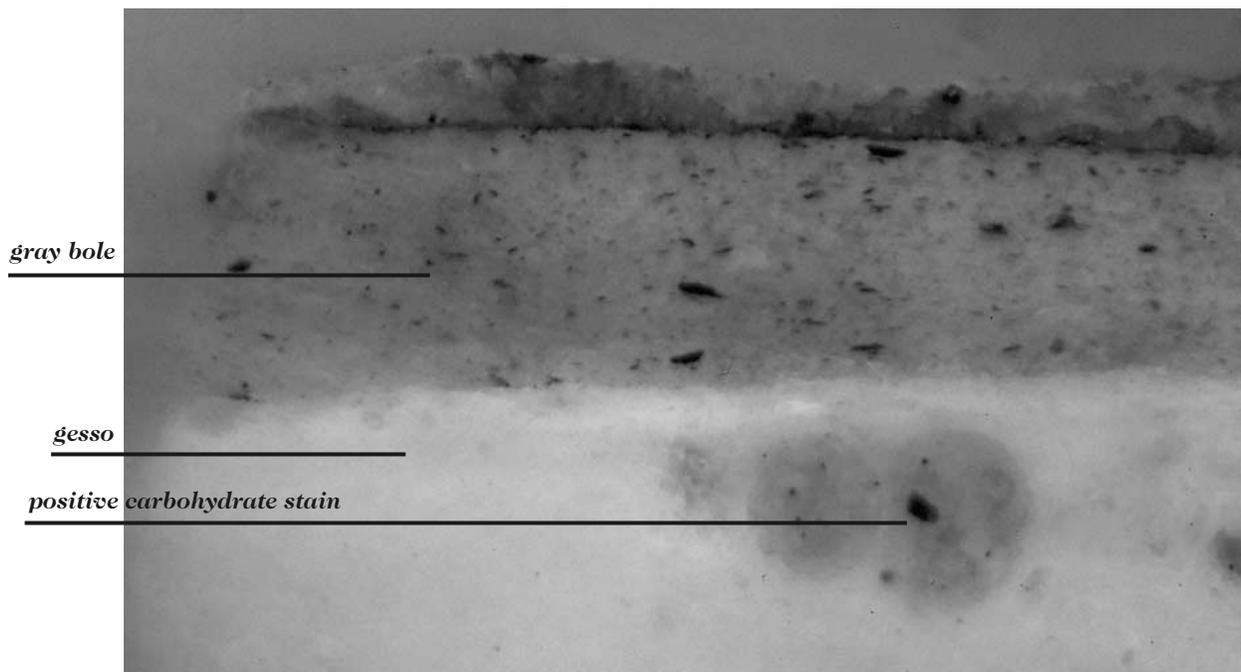
Figure 2: Cross section of gilding layers from the eagle showing gray bole and unusual positive stain reaction for carbohydrates in gesso.

UV light. The gesso layer beneath the bole also appeared similar but had few distinguishing characteristics. While the layer thicknesses varied considerably between all samples, the bole in all samples contained a small amount of a coarse black pigment particle of highly variable size (possibly a charcoal black) as well as a very few isolated red particles of uniform size and morphology. Because of the sparse and somewhat uneven distribution of colored pigment particles and disparate size of black particles encountered, some doubt remained that the two boles were the same. This uncertainty was greatly reduced when the samples were stained with TTC. The upper gesso layer on the eagle (applied directly over the underlying gilding) showed unusual, isolated round zones of strong positive reaction for carbohydrates. The original gesso layers in the water gilding from other areas of the frame reacted to TTC in a very similar manner; the shape, size, distribution, and intensity of the reaction zones was nearly identical. While the precise nature of the gesso additive presumably responsible for the positive reaction is not known, the staining certainly suggested that the gesso layers were contemporaneous (*figs. 2 and 3*).

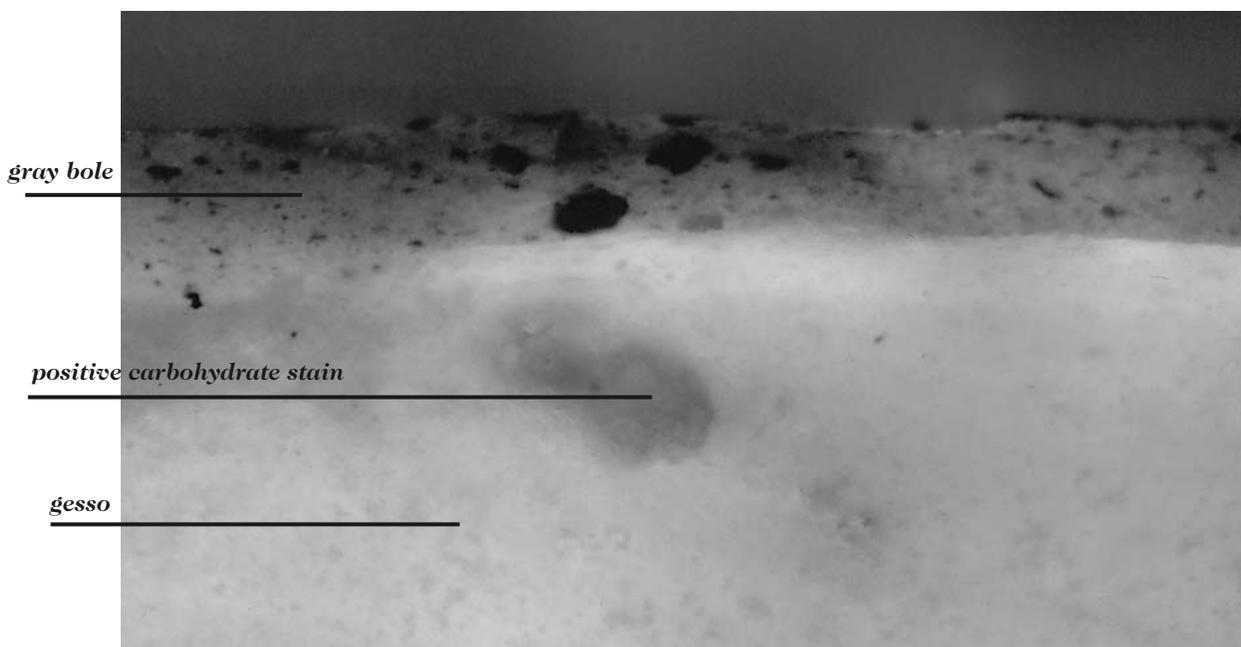
Figure 3: Cross section of gilding layers from the lower frame showing similar gray bole and carbohydrate reaction.

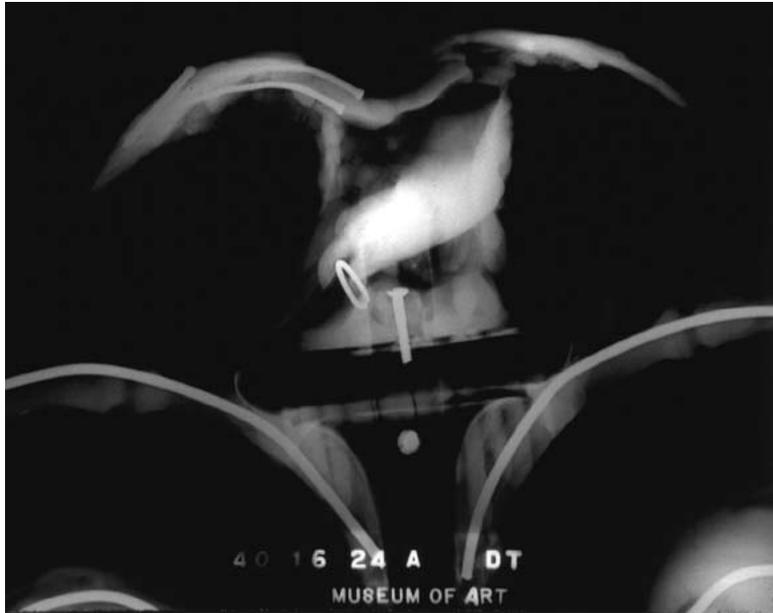
Figure 4: X-radiograph of the eagle showing the nails used in prior wing repairs.

An X-radiograph was then made of the eagle and its perch (*fig. 4*). The film showed two repairs to the proper left wing. One of these repairs, located near the body of the eagle, utilized two cut nails as supporting elements which were embedded in composition putty. The yellow paint on the back of the frame appears to

be continuous over this repair. These nails appear to be the same size and shape as those seen in another X-radiograph of the body of the frame (*fig. 5*) where they were used as part of the original armature for composition ornament (in contrast, the second repair to the wing utilized a wire nail as a support and has been overpainted with what appears to be the same bronze paint used to restore the gilding on the front of the frame).

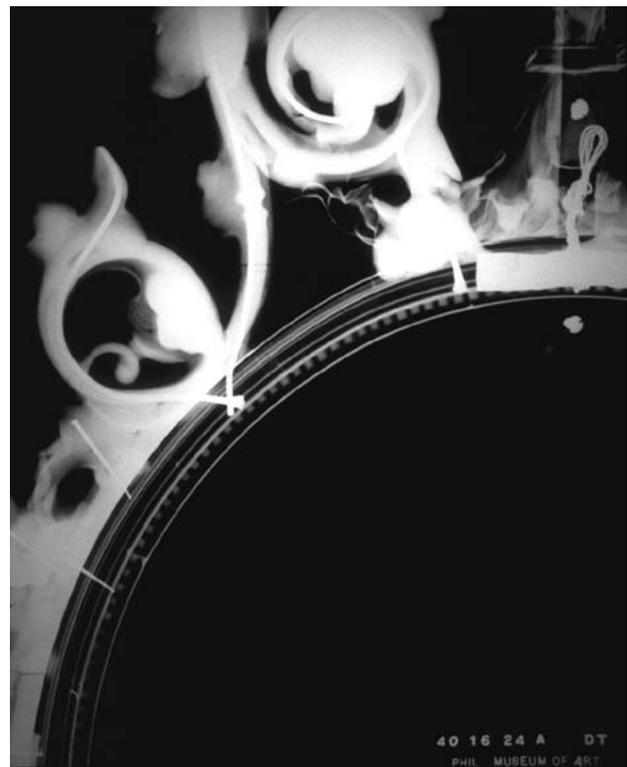
Figure 5: X-radiograph of the upper left quadrant of the frame showing very similar cut nails used as original armature (figures 4 and 5 are not to scale).

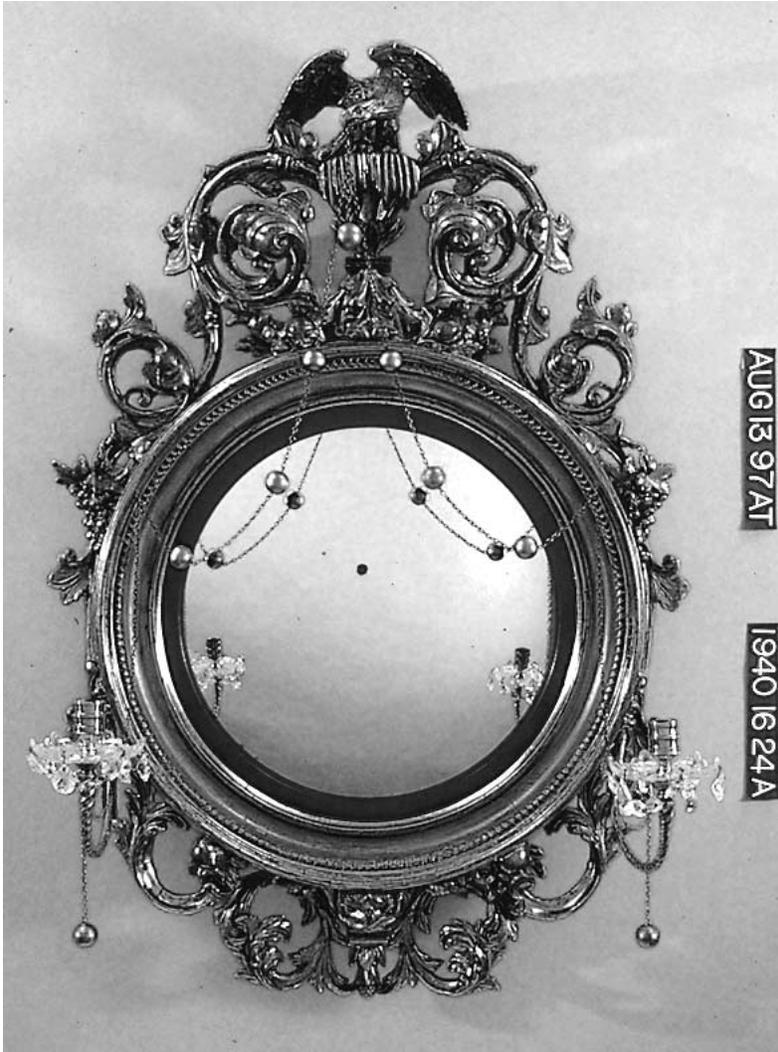
Figure 6: The girandole after treatment showing the final arrangement of balls and chain.

The replacement balls and chain were attached to the frame in an arrangement agreed upon with the curator (*fig. 6*). To attach the chain to the torus molding in the "ten o'clock" and "two o'clock" positions, very fine stainless steel "insect pins"

were bent and clipped into a figure "P", with the opening just large enough for a link of chain to be inserted. Two very fine holes were then drilled into the frame 1/2" above the locations indicated by the X-radiographs. The site was shifted slightly to avoid disturbing the site of possible original attachment in case further investigation should be carried out at a later date. The insect pins were then glued into the holes with B-72 acrylic adhesive and the new chain was attached.

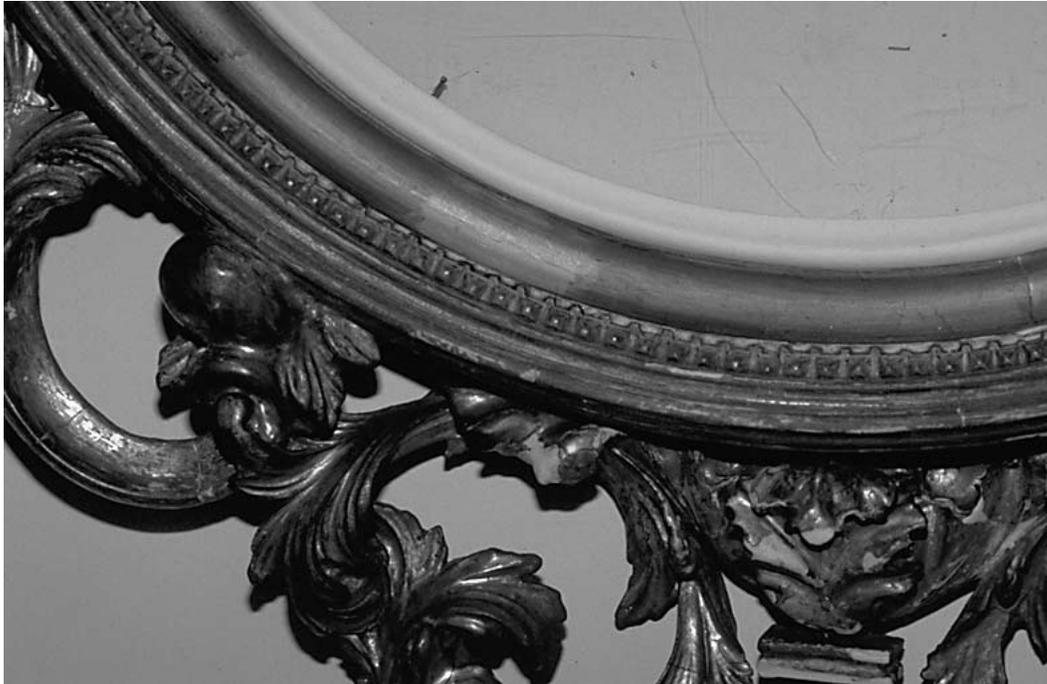
Figure 7: Detail of cove molding showing an area cleaned with triammonium citrate gel surrounded by areas cleaned with saliva.

The gel was brushed on and allowed to sit for between 30 seconds and one minute. It was then removed using cotton swabs and cleared well with deionized water. This chelating solution, based on triammonium citrate, was found to be significantly more effective than saliva at removing surface soil (*fig. 7*).

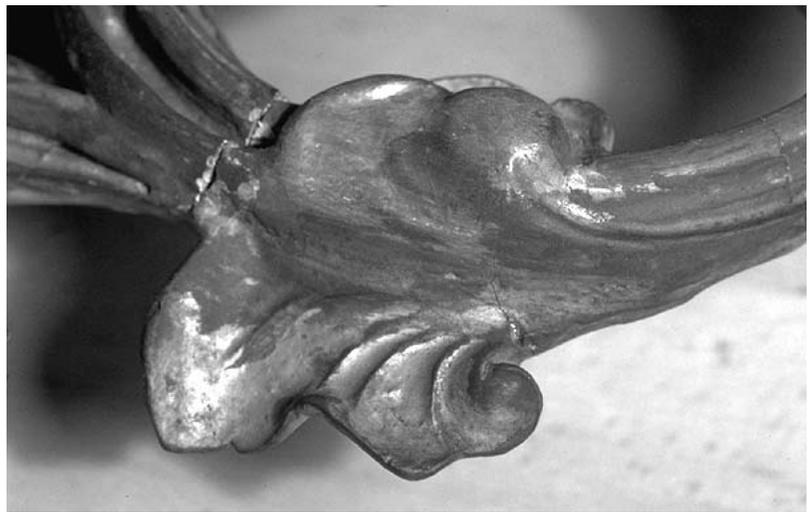
Figure 8: Detail of the girandole before treatment showing darkened bronze paint.

First, the bronze paint was mechanically reduced with a 0000 steel wool swab, working under magnification. The chelating gel, though effective, acted fairly slowly on the bronze paint, and this initial mechanical reduction allowed the removal to proceed more quickly. The gel was then brushed on and allowed to sit for between two and ten minutes, agitating periodically with a soft brush, until it became quite green from absorbed copper compounds. Using these solutions in gel form allowed them to sit for long periods of time on the surface without the risk of spreading onto water sensitive areas of water gilding. The bulk of the gel was then removed with the brush and the residue was cleared with deionized water. The process was

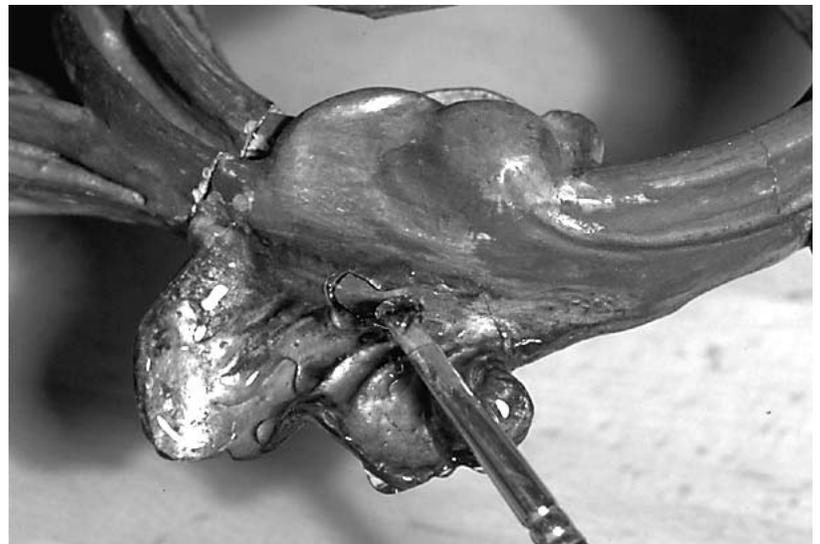
Figure 9: Same area as figure 8, with chelating gel applied.

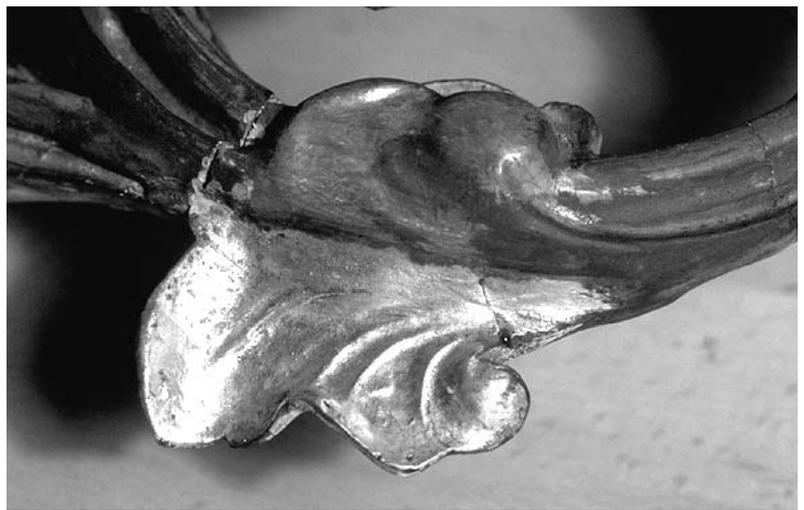
Figure 10: Same area as figure 8, after bronze paint removal.

repeated one or more times as needed. Since it was thought that the oil size might be softened slightly by prolonged exposure to water, any given area of surface was allowed to dry for at least several hours before retreating. In fact, no new damage to the underlying gilding was observed during this treatment (*fig. 8, 9, and 10*). It is not known what the binder of the girandole's bronze paint was. Media analysis by staining and fluorescence microscopy was inconclusive since the layer was entirely non-fluorescent under ultraviolet light.
