# The Examination and Treatment of an American Gilded Girandole, ca. 1830

Arlen Heginbotham

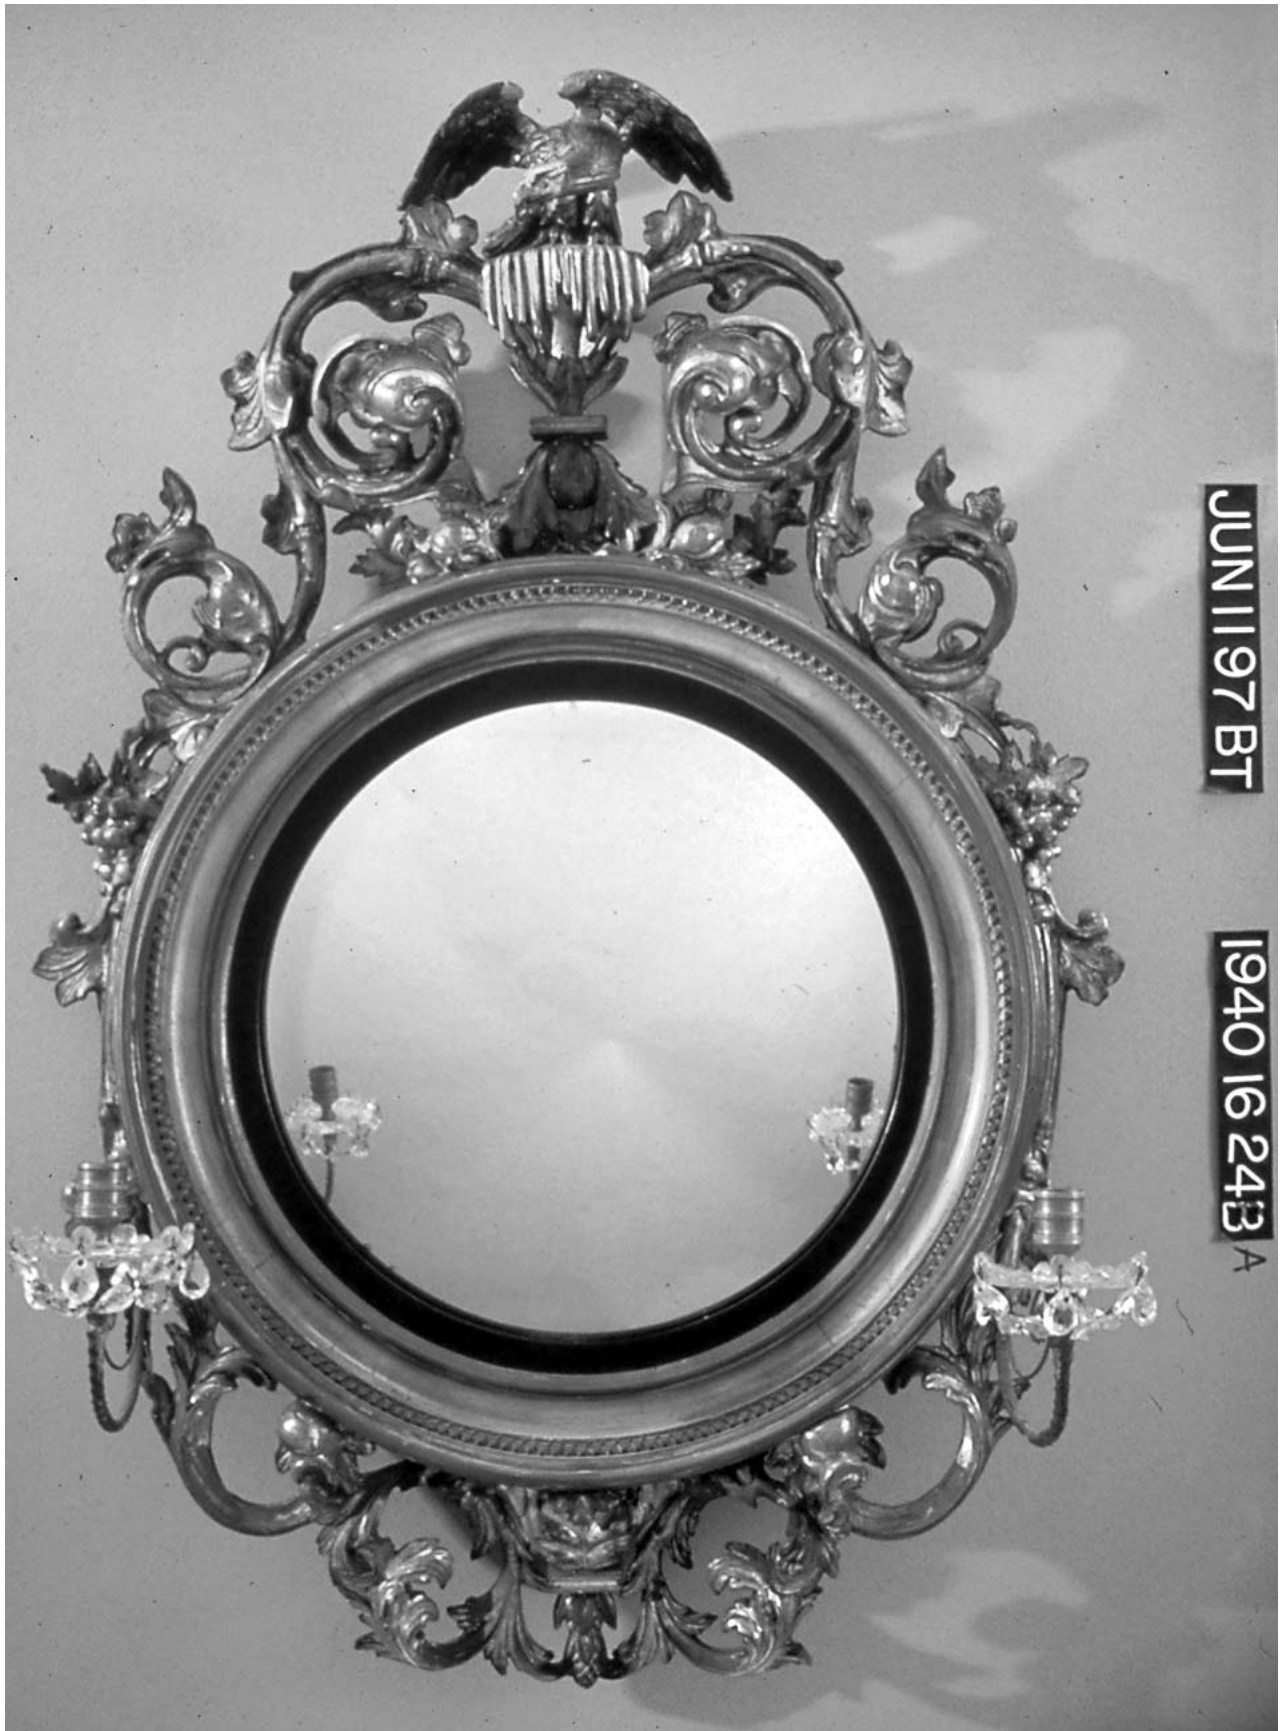
*Figure 1: The girandole before treatment.*

In general, the girandole was in good condition. There was a significant accumulation of dirt and soil on the surface, and in a few localized areas, the gilding exhibited some minor flaking. The girandole had been liberally restored with bronze paint, which had since darkened considerably and was quite disfiguring. There were several areas of substantial loss, including a large acanthus leaf element just above the molded wooden frame at the center; a large section of the twist decoration on the proper left candle arm; and the total loss of the gilded balls and chain which would originally have hung on the frame.

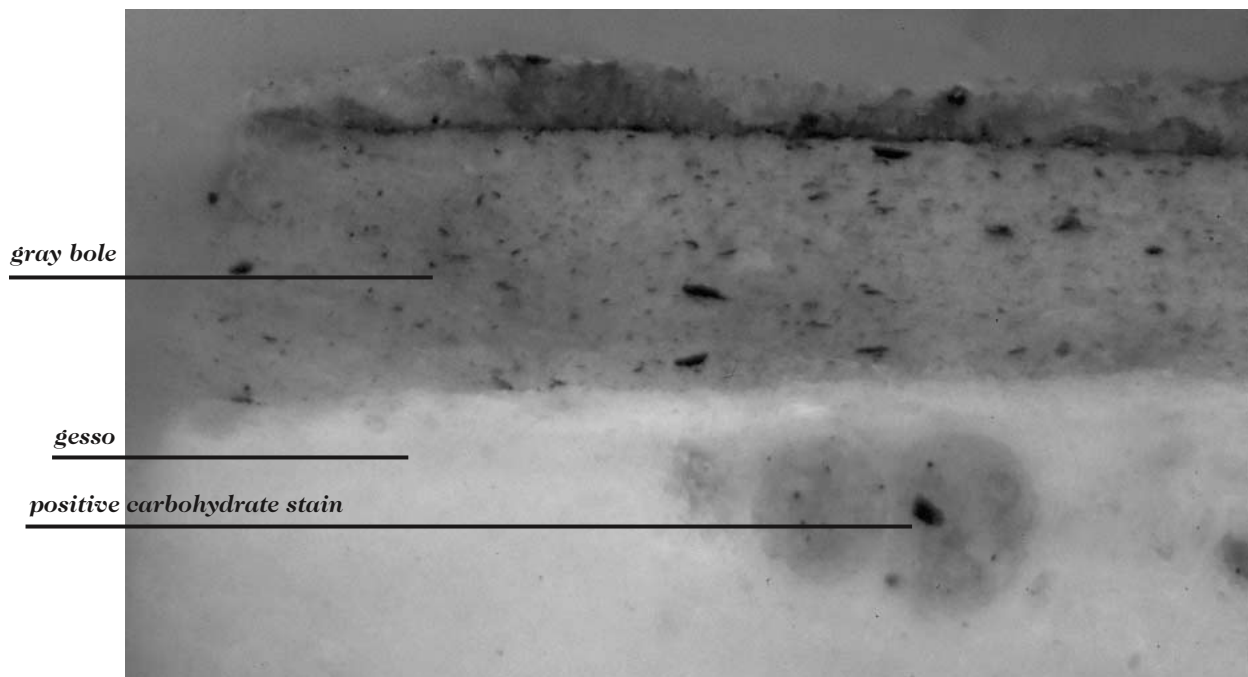
*Figure 2: Cross section of gilding layers from the eagle showing gray bole and unusual positive stain reaction for carbohydrates in gesso.*

UV light. The gesso layer beneath the bole also appeared similar but had few distinguishing characteristics. While the layer thicknesses varied considerably between all samples, the bole in all samples contained a small amount of a coarse black pigment particle of highly variable size (possibly a charcoal black) as well as a very few isolated red particles of uniform size and morphology. Because of the sparse and somewhat uneven distribution of colored pigment particles and disparate size of black particles encountered, some doubt remained that the two boles were the same. This uncertainty was greatly reduced when the samples were stained with TTC. The upper gesso layer on the eagle (applied directly over the underlying gilding) showed unusual, isolated round zones of strong positive reaction for carbohydrates. The original gesso layers in the water gilding from other areas of the frame reacted to TTC in a very similar manner; the shape, size, distribution, and intensity of the reaction zones was nearly identical. While the precise nature of the gesso additive presumably responsible for the positive reaction is not known, the staining certainly suggested that the gesso layers were contemporaneous (*figs. 2 and 3*).

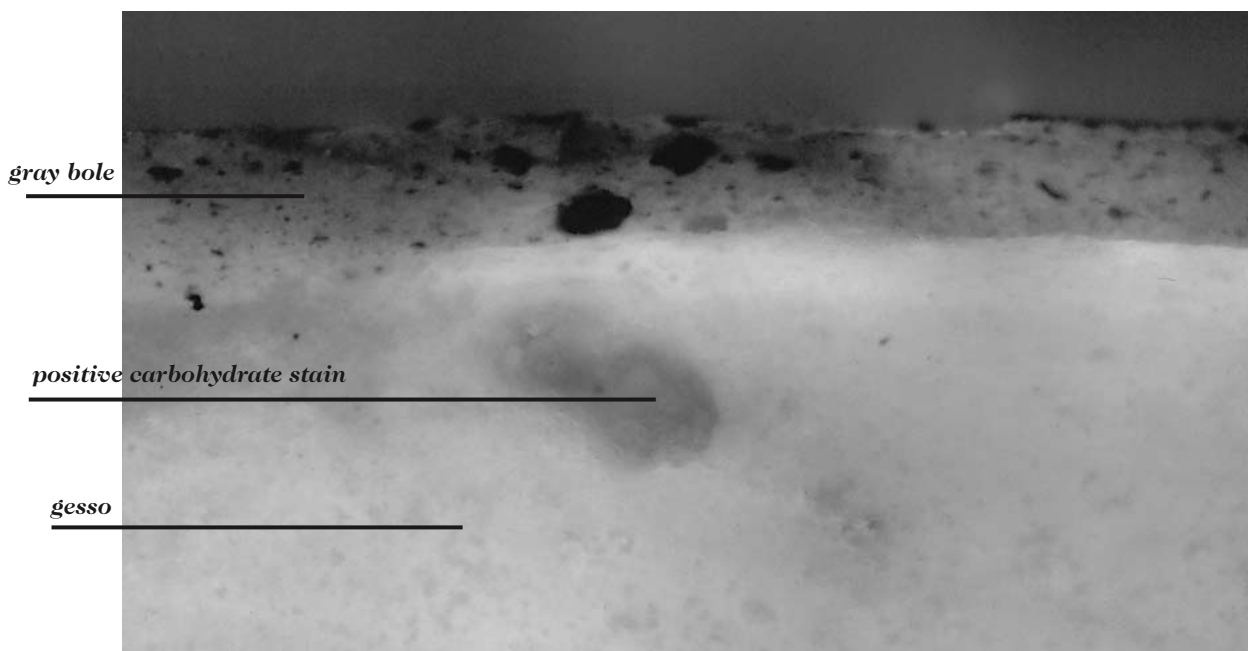
*Figure 3: Cross section of gilding layers from the lower frame showing similar gray bole and carbohydrate reaction.*

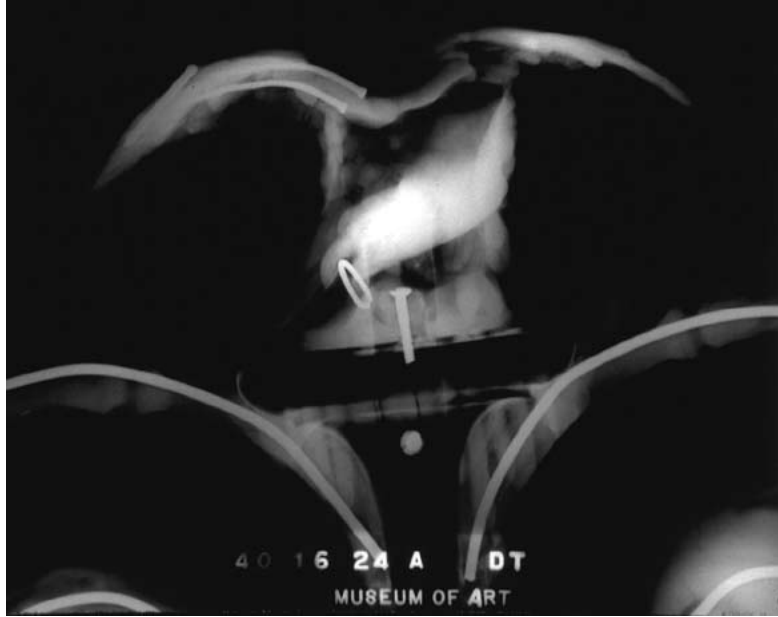
*Figure 4: X-radiograph of the eagle showing the nails used in prior wing repairs.*

An X-radiograph was then made of the eagle and its perch (*fig. 4*). The film showed two repairs to the proper left wing. One of these repairs, located near the body of the eagle, utilized two cut nails as supporting elements which were embedded in composition putty. The yellow paint on the back of the frame appears to

be continuous over this repair. These nails appear to be the same size and shape as those seen in another X-radiograph of the body of the frame (*fig. 5*) where they were used as part of the original armature for composition ornament (in contrast, the second repair to the wing utilized a wire nail as a support and has been overpainted with what appears to be the same bronze paint used to restore the gilding on the front of the frame).

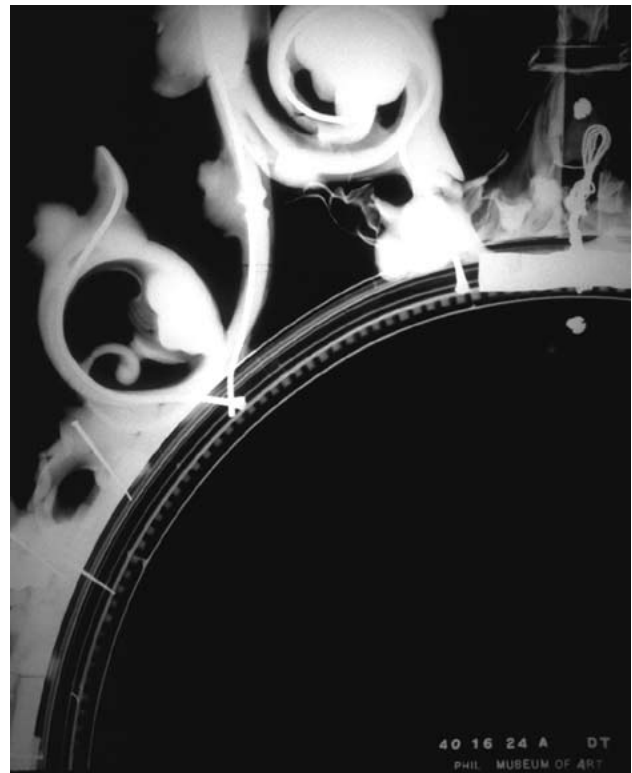
*Figure 5: X-radiograph of the upper left quadrant of the frame showing very similar cut nails used as original armature (figures 4 and 5 are not to scale).*

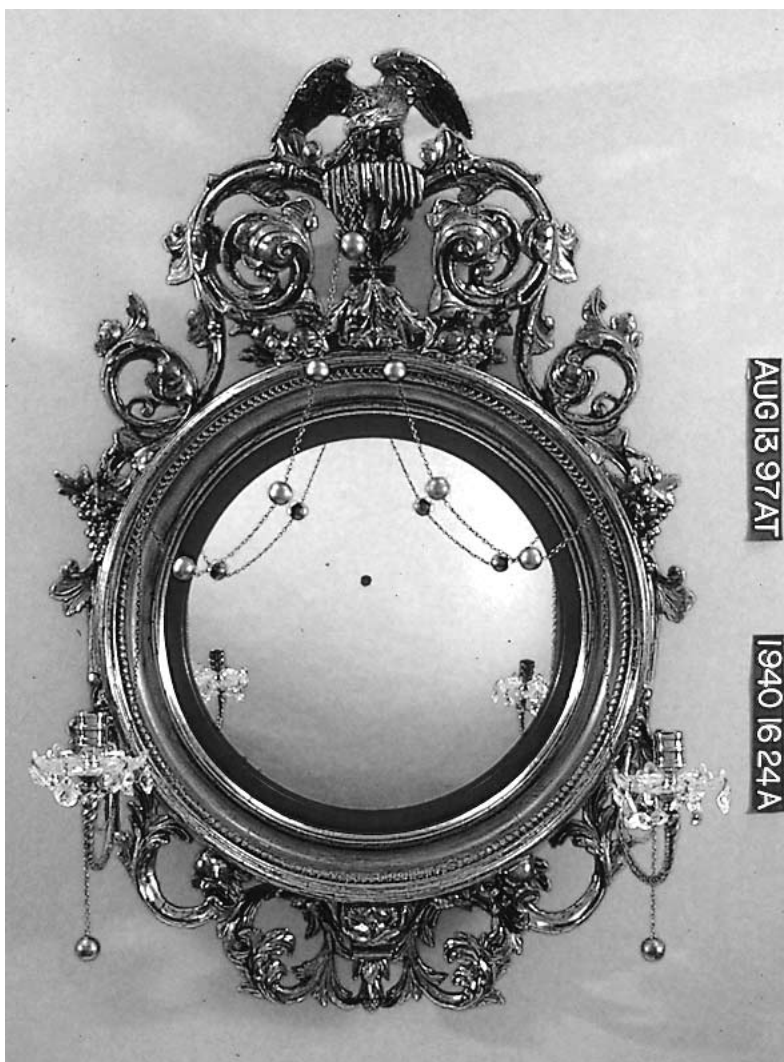
**Figure 6: The girandole after treatment showing the final arrangement of balls and chain.**

The replacement balls and chain were attached to the frame in an arrangement agreed upon with the curator (*fig. 6*). To attach the chain to the torus molding in the "ten o'clock" and "two o'clock" positions, very fine stainless steel "insect pins"

were bent and clipped into a figure "P", with the opening just large enough for a link of chain to be inserted. Two very fine holes were then drilled into the frame 1/2" above the locations indicated by the X-radiographs. The site was shifted slightly to avoid disturbing the site of possible original attachment in case further investigation should be carried out at a later date. The insect pins were then glued into the holes with B-72 acrylic adhesive and the new chain was attached.

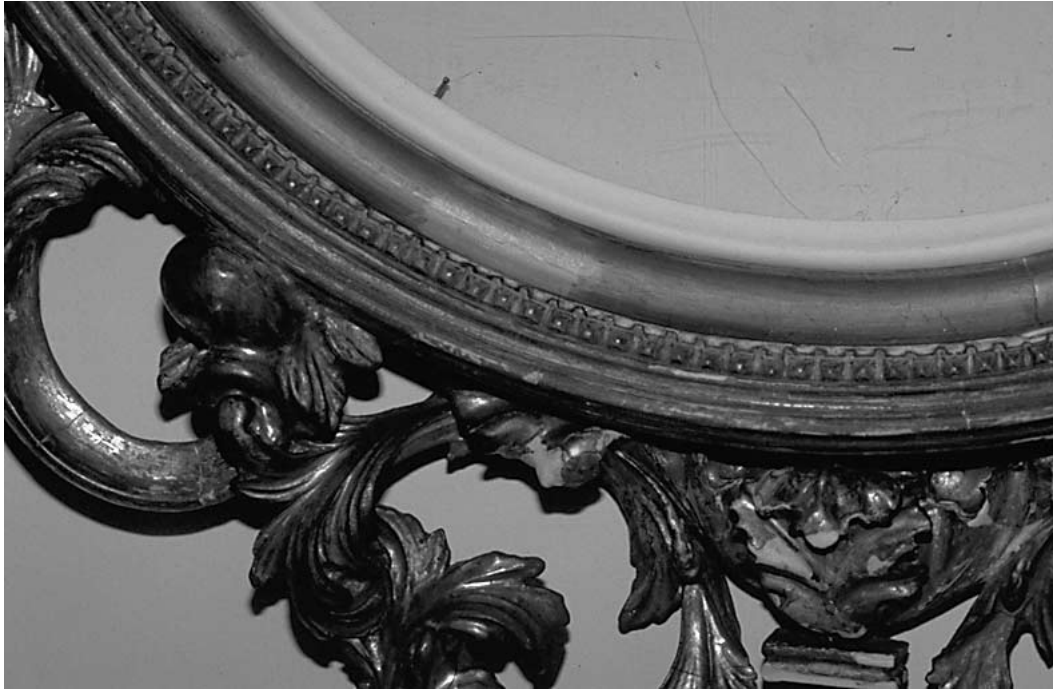
*Figure 7: Detail of cove molding showing an area cleaned with triammonium citrate gel surrounded by areas cleaned with saliva.*

The gel was brushed on and allowed to sit for between 30 seconds and one minute. It was then removed using cotton swabs and cleared well with deionized water. This chelating solution, based on triammonium citrate, was found to be significantly more effective than saliva at removing surface soil (*fig. 7*).

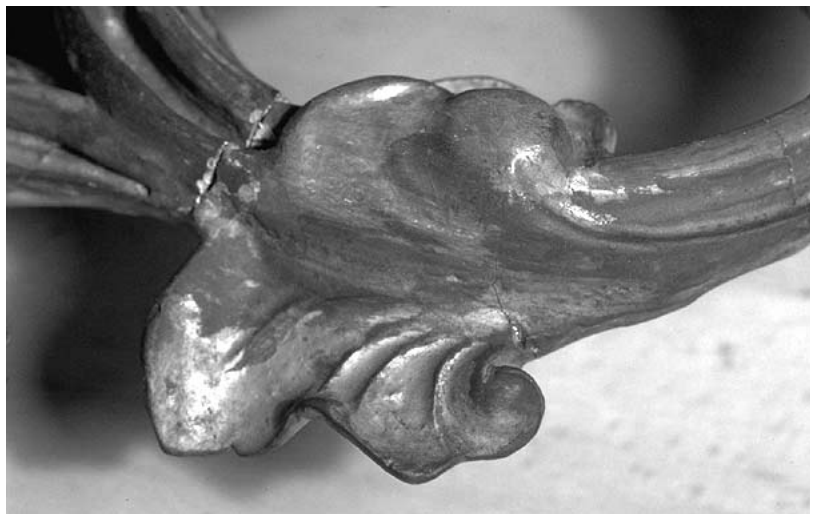
*Figure 8: Detail of the girandole before treatment showing darkened bronze paint.*

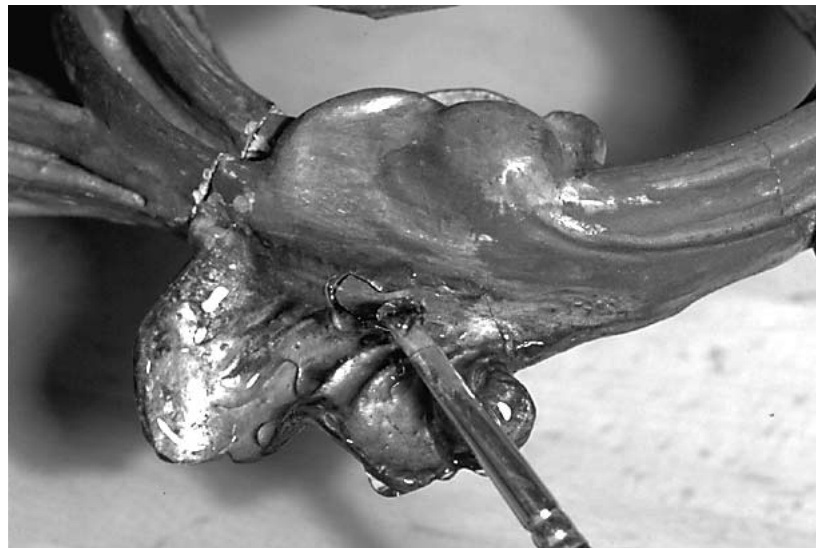
*Figure 9: Same area as figure 8, with chelating gel applied.*

First, the bronze paint was mechanically reduced with a 0000 steel wool swab, working under magnification. The chelating gel, though effective, acted fairly slowly on the bronze paint, and this initial mechanical reduction allowed the removal to proceed more quickly. The gel was then brushed on and allowed to sit for between two and ten minutes, agitating periodically with a soft brush, until it became quite green from absorbed copper compounds. Using these solutions in gel form allowed them to sit for long periods of time on the surface without the risk of spreading onto water sensitive areas of water gilding. The bulk of the gel was then removed with the brush and the residue was cleared with deionized water. The process was

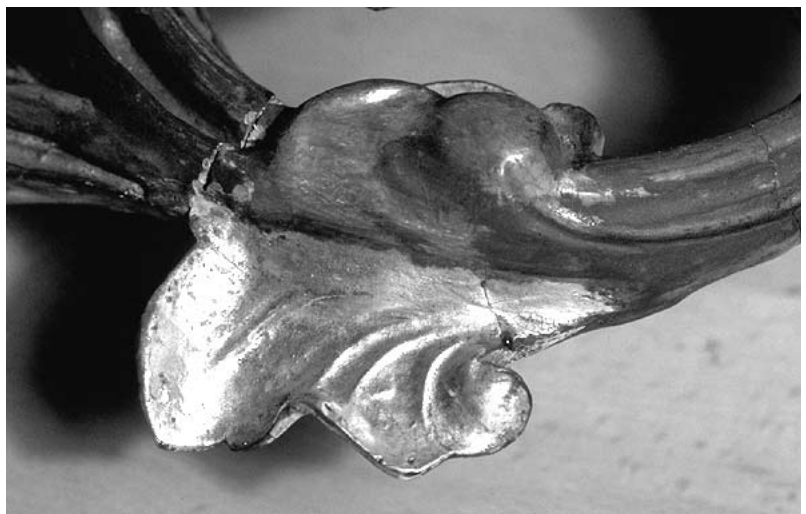
*Figure 10: Same area as figure 8, after bronze paint removal.*

repeated one or more times as needed. Since it was thought that the oil size might be softened slightly by prolonged exposure to water, any given area of surface was allowed to dry for at least several hours before retreating. In fact, no new damage to the underlying gilding was observed during this treatment (*fig. 8, 9, and 10*). It is not known what the binder of the girandole's bronze paint was. Media analysis by staining and fluorescence microscopy was inconclusive since the layer was entirely non-fluorescent under ultraviolet light.
