# UPHOLSTERY CONSERVATION

by Kathryn J. Gill\*

The aim of this presentation is to highlight, through a series of case histories, some recent developments, typical problems and practical considerations involved with the conservation of textile coverings and foundation materials attached to the frames of museum quality seat furniture. Emphasis is placed on some tried and tested methods of re-attaching the original textile elements to their frames, after conservation treatment.

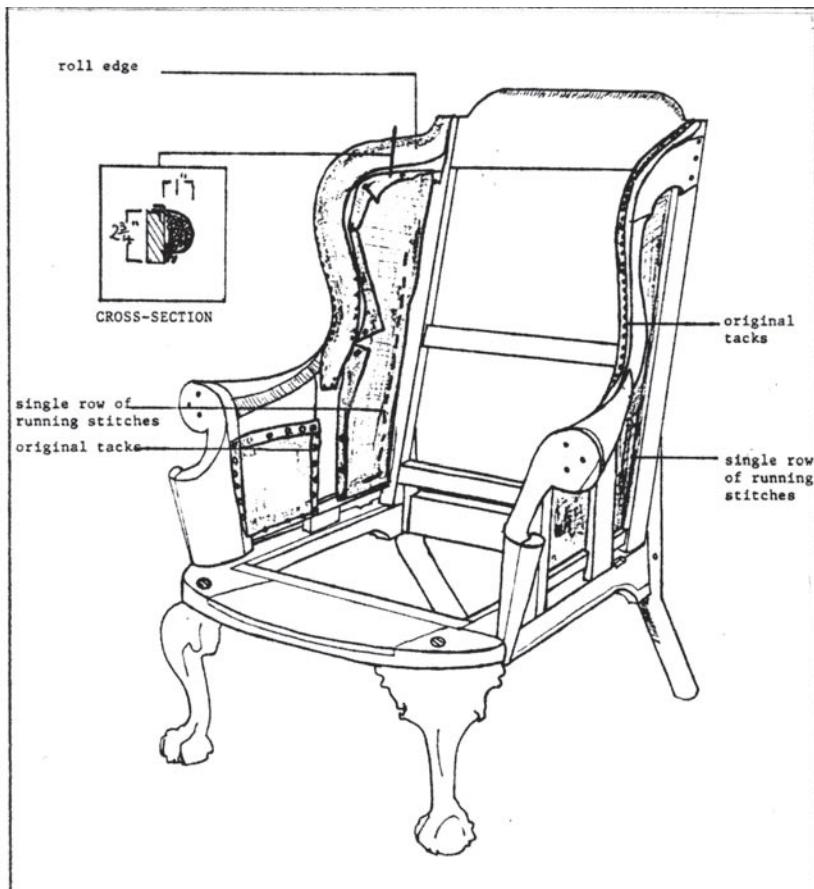
Fig. 1 - Diagram showing the first linen layer and roll edge

The main body of the top linen layer and the layer covering the roll edge were structurally quite sound. However, due to a combination of the sharp edges of the embedded tack heads and the repeated addition and removal of tacks, staples and nails from subsequent upholstery coverings, the area of linen around the tack line of the wings was no longer attached to the wood frame. The tack line area around the outer arm and the panels in the top linen layer and the first linen layer were more intact; however, the threads

surrounding most of the tacks had been severed by the embedded tack heads. The linen twines holding the hair filling to the first linen layer ripped through the weakened linen at these points due to the weight of the unit of curled hair filling. The hair although slightly flattened, had retained its basic shape and remained quite flexible. The straw filling making up the roll edge was very brittle.

Due to its weakened condition, the linen encasing the straw forming the roll edge was worked on in situ. It was supported with a layer of nylon net. A polyester crepline fabric was considered as an alternative support fabric because of its longevity, however, the nylon net was preferred since its somewhat elastic qualities, due to the bobbin net structure, eased well over and around the changing contours of the three-dimensional form. In addition, the nets ability to grip rather than slip over the surface of the

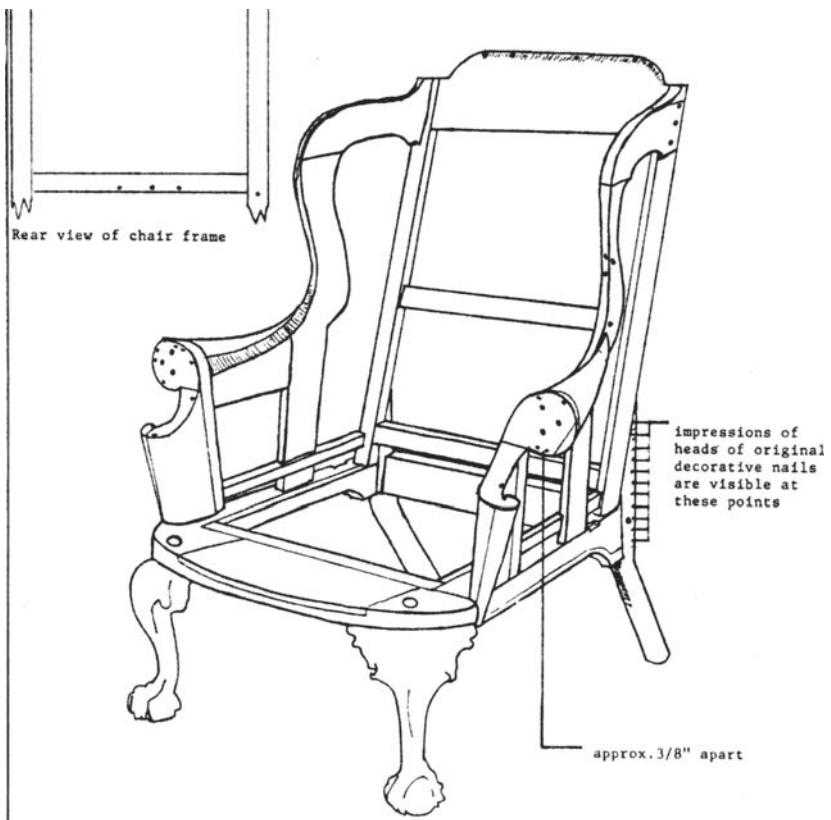
Fig. 3 – Diagram showing location of remaining original brass shanks

Examination of the tack holes on the frame revealed that the frame had been re-upholstered many times. Additionally, several brass shanks of square cross-section were found embedded in the wood frame. This suggested that the chair was originally finished with decorative nails (figs. 3 & 4). It was surmised that originally the nails extended around the face of each scroll, along the front and side edges of each wing, the outer arm, the top edges of the upper back and the two outer edges of the back upright. The nails probably extended along the lower edge of the side and front seat rail, however, since this section of wood had been replaced at some point, there is no evidence to support this assumption.

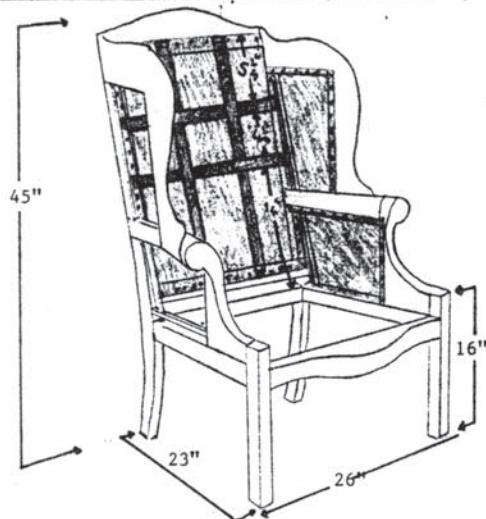
Fig. 5

The inside back has an open interlaced layer of webbing, 2 x 2 arrangement; the webbing is 1 3/4" wide and has a chevron weave.

A single layer of linen is tacked over the inner back, inner wings and inner sides.

The curled hair filling lies directly over the linen. The hair is probably held in place with linen ties, i.e. loops of twine, stitched through the hair and the lower linen layer.

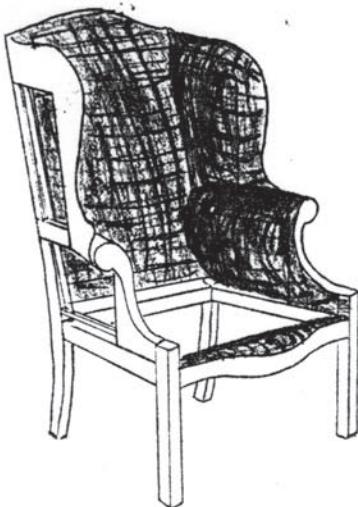
Fig. 6

Upholstered areas: inner back, wings, sides, front seat rail and commode seat; (loose seat cushion and outer slip cover are missing)

Stuffing: curled black, white and brown hair; several small feathers found lodged between upholstery and seat rail suggests the filling in the missing seat cushion was of feathers.

Depth of stuffing: seat rail: center  $\frac{5}{8}$ ", edges  $\frac{3}{8}$ "; commode  $\frac{3}{4}$ "; arm, (deepest point)  $3\frac{1}{2}$ "; wing, (deepest point)  $2\frac{1}{2}$ "; inner back, (deepest point)  $2\frac{3}{4}$ ".

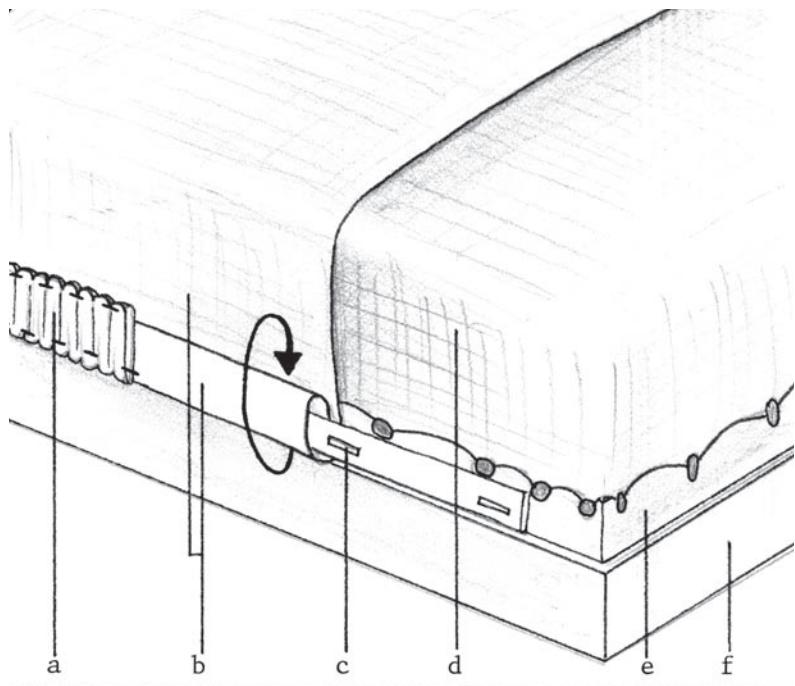
Fig. 7

The silk warp threads, positioned at right angles to the front roll edge, were broken and several of the weft threads had unraveled, exposing a large section of the underlying cotton layer. The foundation upholstery appeared to be in excellent condition.

Diagram of seat corner to show the method of attachment of conserved outer cover and gimp braid.

previous covering. The excess fabric was trimmed and wrapped over the front surface of the card strip, the raw edge being tucked between the card and outer cover. The gimp braid was stitched directly to the support fabric and to the cover, (fig. 7).

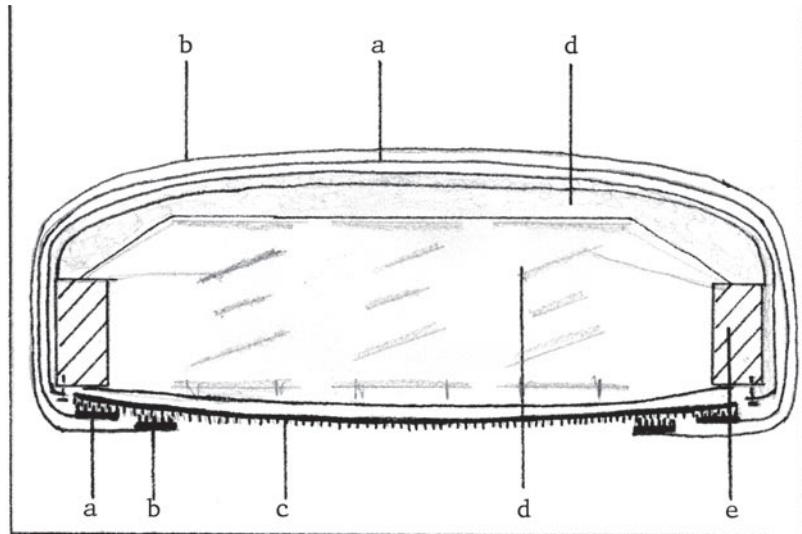
Fig. 8 - Cross-section of the upholstered seat to show the method of attachment of the protective cover and the slip cover to the 'velcro' fabric panel.

The silk covering the seat and inner and outer back was extremely fragile and was too weak to remove for treatment without the risk of being irreparably damaged. The convex contoured seat and inner back upholstery units offered a degree of support to the silk panels. Unfortunately, the outer back panel, not having this additional support, had pulled away from the upper tack edge. As a last resort in order to save this unsupported brittle panel, a decision was made to remove it completely. It was mounted and placed into flat storage.

The seat cover support was designed to wrap around and attach to the underside of the seat; likewise, the back cover attached to the rear back panel. To keep the construction simple, and to obtain a close fit over the curved surface of the seat, the support cover was edged with 'velcro' and attached to a corresponding panel of 'velcro' fabric laid over the underside of the frame.

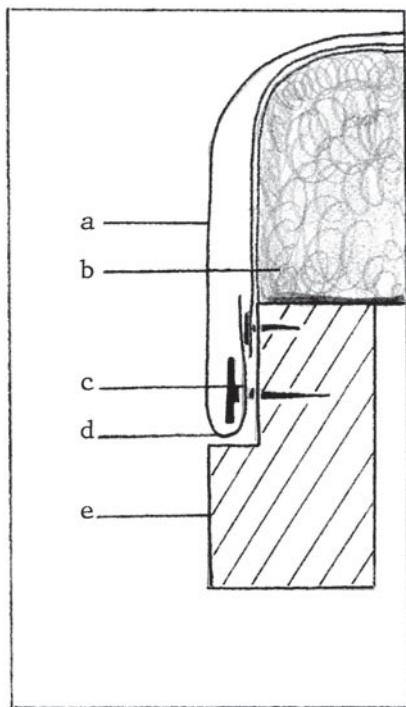
Fig. 9 - Cross-section view of the seat upholstery to show the original method of attachment to the outer cover.

The silk fabric is very weak. Due to the combination of the stress subjected to the warp and weft along the folded edge of the silk cover and earlier repair work along this same line, the cover has become separated from the frame.
