CONSERVATION OF AN EBENEZER TRACY SETTEE*

Michael Sandor Podmaniczky
Associate Furniture Conservator
Henry Francis DuPont Winterthur Museum

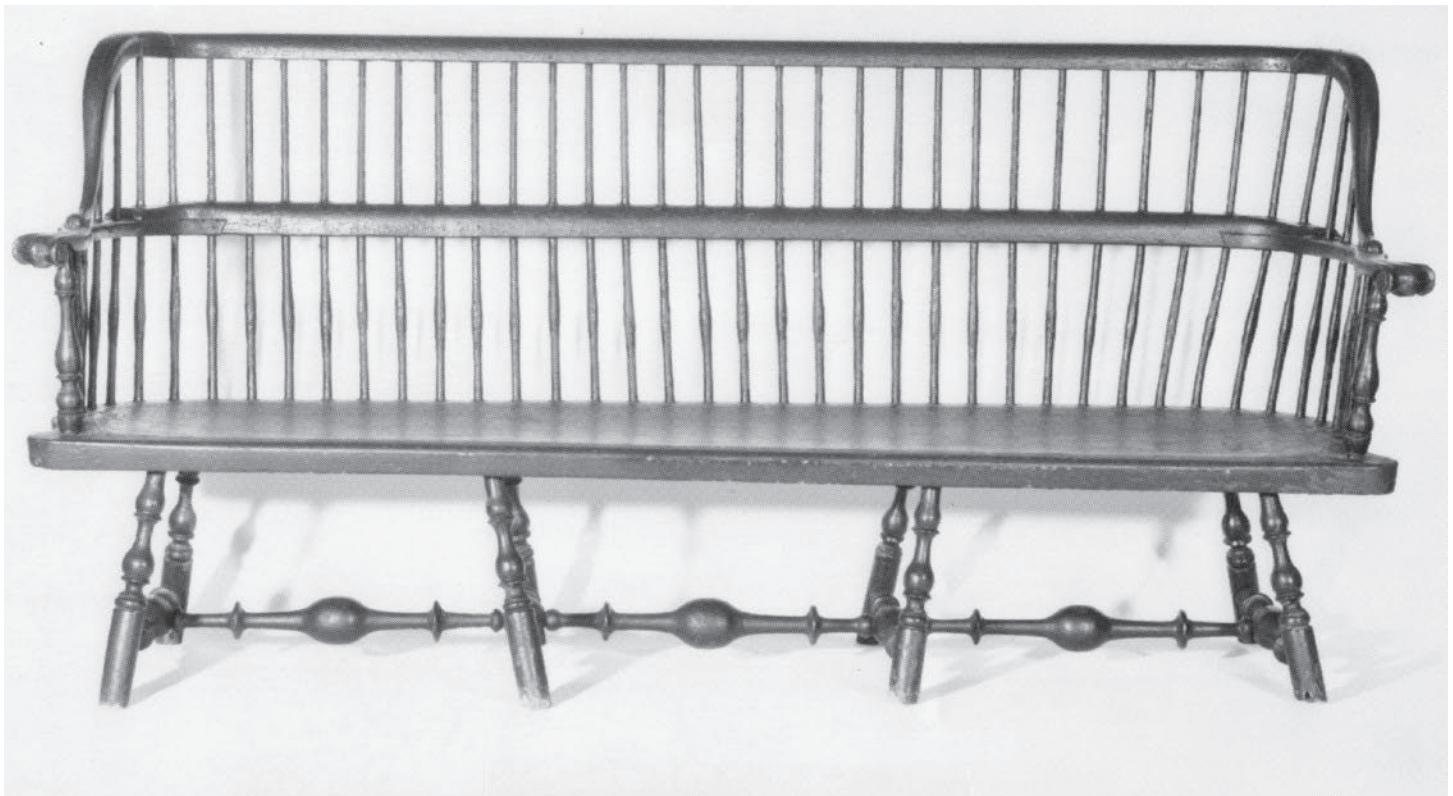
Before Treatment

encouraging fungal attack in the four front feet, and subsequent wood loss. The loss, unfortunately for the settee, was uneven: approximately 2" was lost from the proper left front foot, with incrementally less from each adjacent foot, ending up with a loss of only about 3/4" from the proper right foot. The rear feet, strangely enough, were spared. Areas of soft, degraded wood, were, for the most part, confined to the interior of each foot, indicating that the piece had been placed back in service after fungal attack had seriously weakened the wood structure. This had the effect of mechanically sloughing off wood wherever the rasping of the floor could do its work, leaving a shortened and jagged, but nonetheless fairly rigid shell of wood, with a soft, excavated inner core, extending up and into the center of each leg.

Many seasonal cycles must have passed with the settee in this condition, because the lack of support by the proper left front feet caused a constant torque to be applied to the seat plank, causing a permanent twist of approximately 1 1/2" out of plane to be induced into the entire piece. The twist in the seat was transferred to the back structure which, true to the plastic qualities of this furniture form, followed suit...to a point. Spindles were loosened and twisted from their sockets, and the proper left arm post broken where it entered the seat socket.
