A REVIEW OF THE CONSOLIDATION SYSTEM USED IN THE CONSERVATION OF A JAPANNED CLOCK

Deborah Bigelow, Conservator and Liz Hickey, Associate Conservator, DEBORAH BIGELOW & ASSOCIATES, 177 Grand Street, Newburgh, New York 12500.

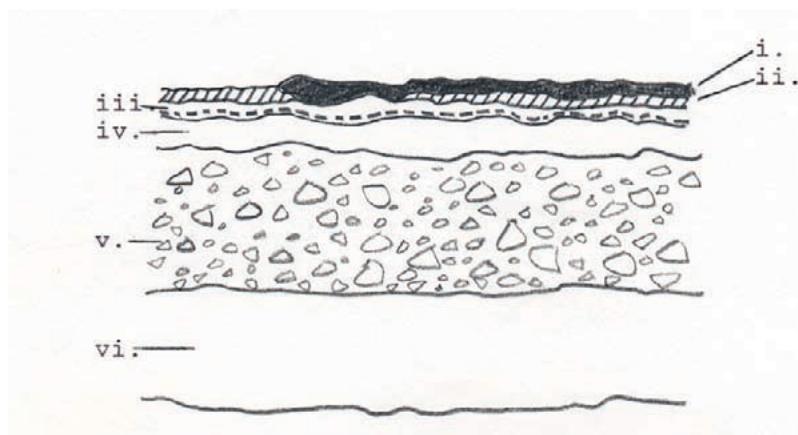
The following list identifies the strata which remain on the clock and does not include the additional restoration materials which were removed during the conservation treatment. Samples were taken from a raised design along the crack in the case door and from decorated areas on the bonnet and analyzed using fluorescence microscopy which confirmed the knowledge we gathered from our empirical observations and primary source research. (Endnote 2) The notations in the margin identify the layers found in the cross-section diagrammed below.

Restoration Layers (retained during treatment)

Black pain line decoration
Crimson paint glaze

- i. Metallic ("bronzing") powders in an oil medium
- ii. Shellac

Earliest/Original Layers

- iii. *Oil-rich varnish layers
 - Black linear decoration
 - Crimson paint glaze
 - *Gold powder and red powder pigment in oil-rich varnish
 - Red ground
 - Raised gesso decoration
- iv. Varnish layers without blue pigment particles
(not fluorescing as strongly for oil)
- v. Varnish layers with blue pigment particles
(not fluorescing as strongly for oil)
- vi. Casein ground
Wood (white oak)
