## EXAMINATION AND TREATMENT OF A GERMAN GILDED CONSOLE TABLE, circa 1740

Gordon Hanlon  
J. Paul Getty Museum

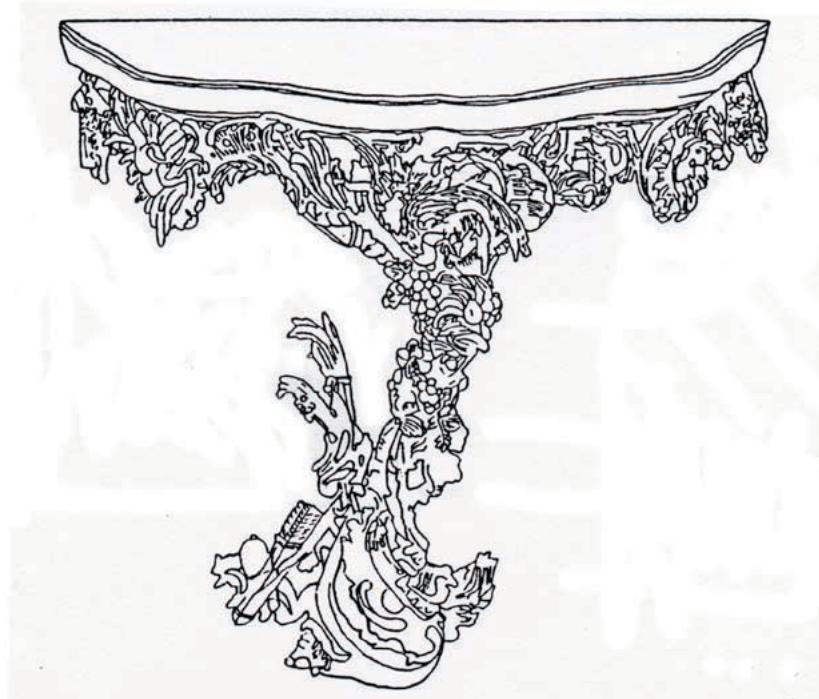
German gilded console table, circa 1740

As both the structure and surface of the console were stable when it was acquired in 1985, it was placed on exhibit without being treated. In 1989, however, a closer examination of the table was performed. The surface quality of the table appeared to be heavily covered with over layers which had filled in the intricacy of the original carved surface. Areas of flaking gilding, especially on the grapes, revealed a vivid orange color beneath the surface. With the curator, we decided to look for a layer of original gilding underneath the existing surface.

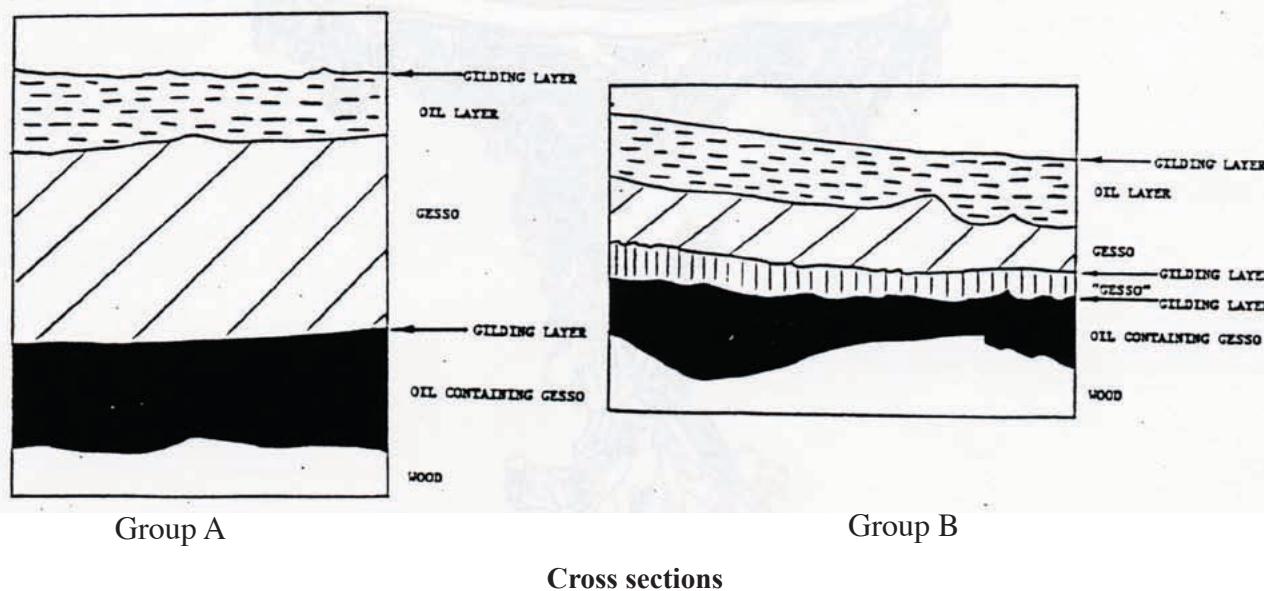
Cross sectional samples were taken from a number of locations on the table to clarify the layer structure of the surface coatings. Examination of these cross sections using visible light and UV microscopy in conjunction with autofluorescent dyes showed that the samples could be divided into two similar but distinct groups, showing two or three gilded layers respectively. The first group of cross sections contained an oil rich gesso which had been applied to the wood, followed by an oil gilding layer. This was covered with a thick gesso, followed by a bright orange oil size, gilding, and a final covering of shellac. The second group of cross sections, however, included two additional layers between the lowest gilded layer and the thick gesso layer. These layers comprised a third preparation and gilding layer.

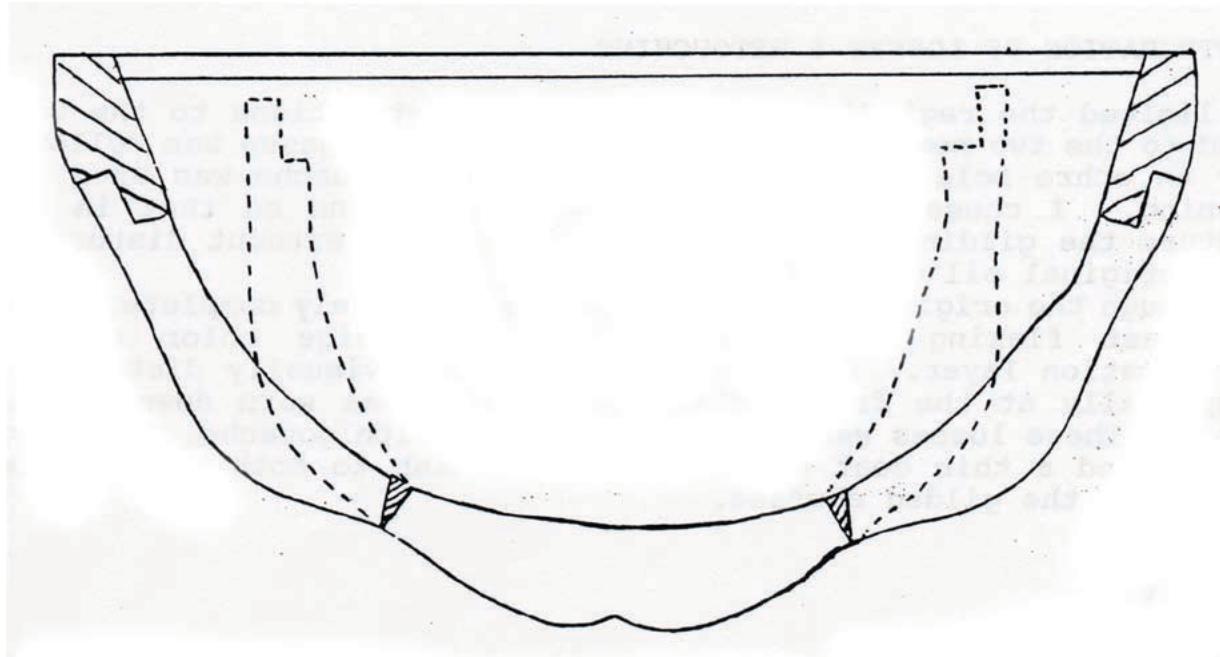
**Original & modified plan view of table top**

Removing the overgilding revealed a major structural alteration to the table. It became apparent that the two ends of the apron which adjoined the wall had been spliced onto the original. Both wood and gilding in these areas differed from the original. Furthermore, the central portion of the apron had been cut in two places to receive wooden wedges (see diagram).

This information, in conjunction with the cross sectional analysis, made it possible to hypothesize the order of the modifications and the gilding layers. Initially the table had been gessoed and oil gilded. At a later date, probably corresponding to its removal from its original room setting, the carved apron was cut in two places, changing the plan view of the table top. The two extensions to the apron enabled it to reach the wall at its new angle. These extensions were carved to simulate the original design. The widening of

the console also required replacement of the back apron. Additionally, the original apron was surmounted with a wide moulding, to which the opened and extended apron could be attached. At this time several losses to the original carving were also recreated and attached to the table. These areas of new wood, as well as adjoining areas of the original, were gessoed and oil gilded. This explains the cross sectional samples which had three layers of gilding.
