The Research and Treatment of a Late 18th-Century Lyre Guitar: A Collaborative Effort

David B. Blanchfield, Winterthur Museum/University of Delaware

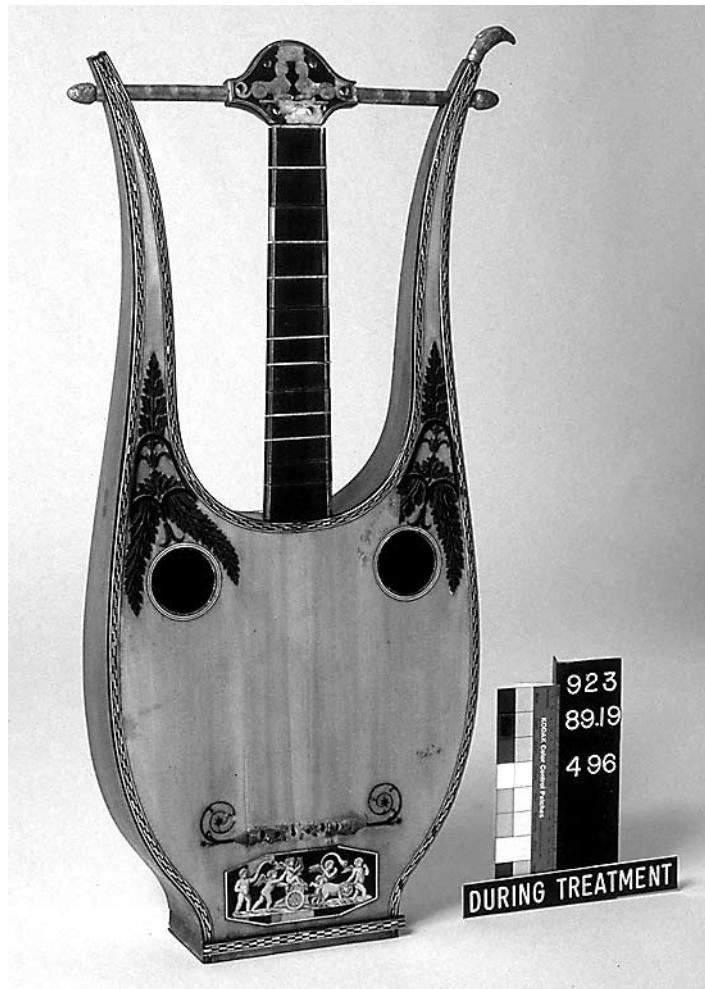
Figure 1. Instrument following structural integration and stabilization.

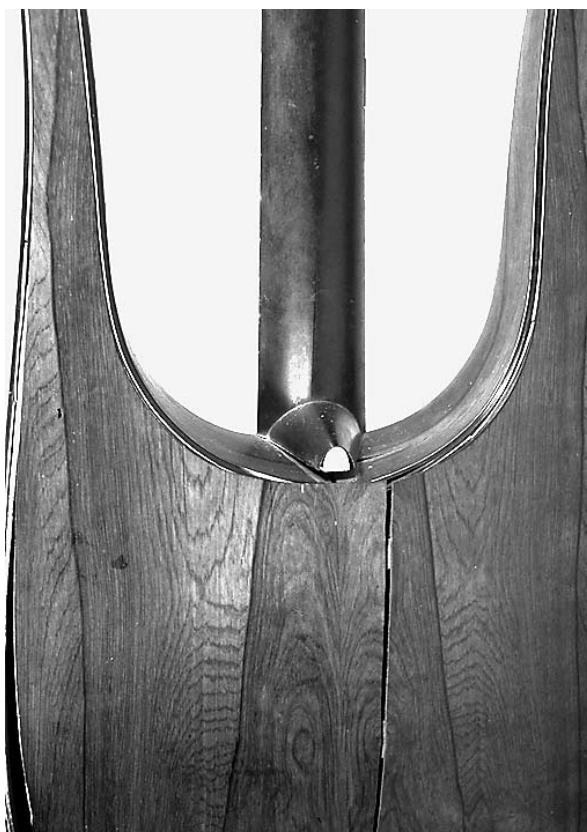
Many, in fact most of the glue joints had failed, notably the side-to-base joint and the neck-to-body joint. The top wood had shrunk across its width causing splits to open at the thinnest points, namely the rabbets for the edge binding. Dimensional change in the substrate had caused pieces of veneer at the headstock, neck, and top inlays, as well as applied decoration to come loose. The same problem had resulted in the loss of approximately

10% of the shell and ivory edge decoration. There were numerous open cracks in the thin wood on all sides of the soundbox. The back was particularly distorted. (fig. 2) Both soundholes would have originally contained pierced ornaments called roses. The Mareschal instrument had lost both of these soundhole roses. They had been replaced by rosewood discs in a previous attempt at repair. Not only were these discs aesthetically jarring, but they were acoustically incorrect as they defeat the purpose of the soundholes which is to allow sound waves to be freely transmitted from the interior to the exterior of the instrument. Finally, the metal elements of the instrument had also suffered from extreme environmental conditions. One of the ormolu eagle head decorations was detached, but still intact. And under magnification, green copper alloy corrosion products were clearly visible beneath the gold overlay in the ormolu yoke.

Figure 2. Back before treatment. Note failed neck and side joints, and split in back plate.

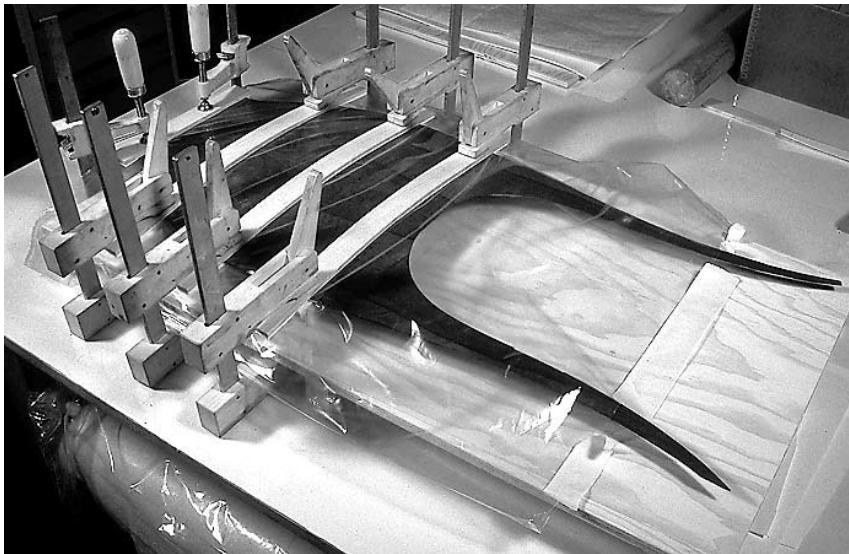
With the back removed, the process of reconforming the plate could begin. Many stringed instruments have arched back and/or top plates to add strength to the soundbox. In the case of this guitar, the back was arched approximately 0.4 cm over 35 cm. The backplate itself had not only lost this arching, but had, segmentally, detached from the remaining back brace and "curled" backwards in the opposite direction.

Figure 3. Back plate in clamping form.

The process used to reconform the back to this arch was gentle humidification of one side of the wood by use of a blotter dampened with deionized water and separated from contact with the wood by a sheet of thin Goretex. This was followed by a period of slow drying. The procedure was performed in much the same way as a paper conservator would approach flattening a page or print. The Goretex allowed vapor phase water to pass to the wood, thus humidifying the material without actually wetting it. Once the back plate had been cycled through three overnight humidification/drying phases, it was relatively flexible and generally planer. At this point, it was placed, under pressure, in a curved form that had been built using the radius of the existing curved back brace as a model. The back was left to dry in the form, wrapped in polyethylene, overnight. (fig. 3)

This entire procedure was repeated several times over the course of a week, at the end of which the back was well arched, and stable in that shape. The open cracks were glued closed using hot hide glue, the loose original brace was reattached, and a new

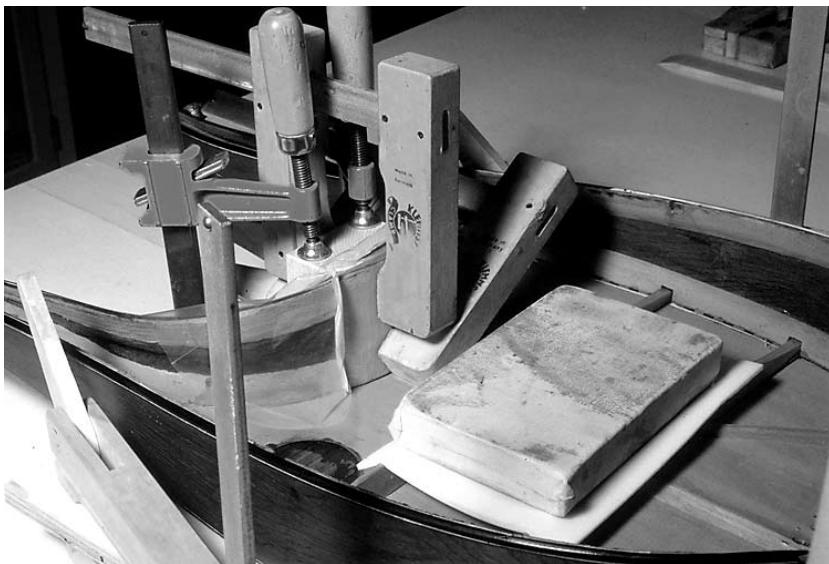
Because the original design of this joint relied solely on adhesive and lacked any mechanical joinery, it was predestined to fail. The joint consists of the two sides sandwiched between a small interior block and the heel of the neck. When the adhesive holding the sides to the neck failed, they began to spring back into the soundbox, pushing the block out of the way. As a result, the neck was completely detached from the body, and

Figure 4. Neck joint with blotter and Goretex clamped to right-angle block.

Again, the blotter and Goretex method was used to ease the sides back into shape for regluing. In this case, however, it was essential that the reformed sides be very close to a 90° angle to the top. Since the neck was built in the same plane as the top, any deviation from this, such as would occur if the sides and top were not at a right angle, would result in the misalignment of the headstock and yoke assembly. It would not be possible to reassemble the neck under these circumstances.

In order to assure a square neck joint, a block was milled to a right angle and clamped to the work board that the guitar lay on. The sides were then clamped to the block while the top was weighted down to the work board. (fig. 4) In this case, the blotter/Goretex/polyethylene sandwich was applied simultaneously to both the interior and exterior of the sides. This resulted in very good conformation after only two humidification cycles and the reglued joint forms an approximate 88° angle to the top.

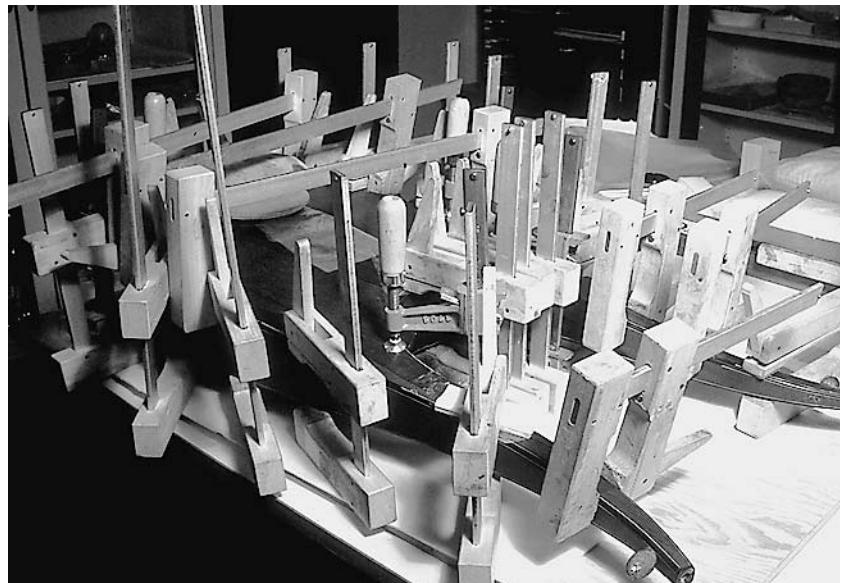
Figure 5. Back plate gluing setup.

Fitting the newly conformed back in place was straightforward enough, but required a number of dry runs to establish a procedure before making an attempt with adhesive. The final assembly was a matter of quickly applying a total of 28 clamps before the hide glue began to gel. (fig. 5) The result is quite acceptable and, although the arch of the reattached back is not absolutely fair, it is much more representative of the original appearance than was previously the case. (fig. 6)

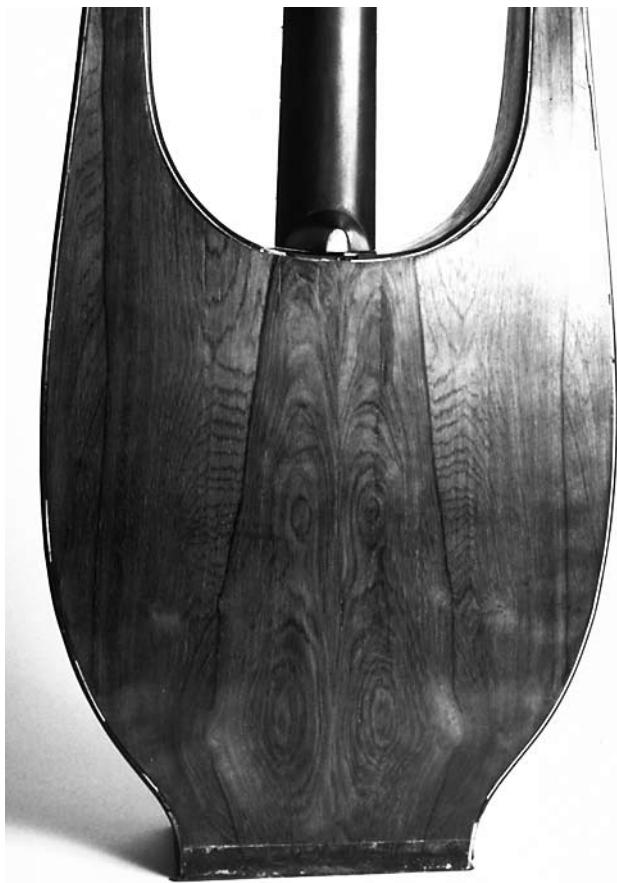
Figure 6. Back following reconformation and re-attachment.

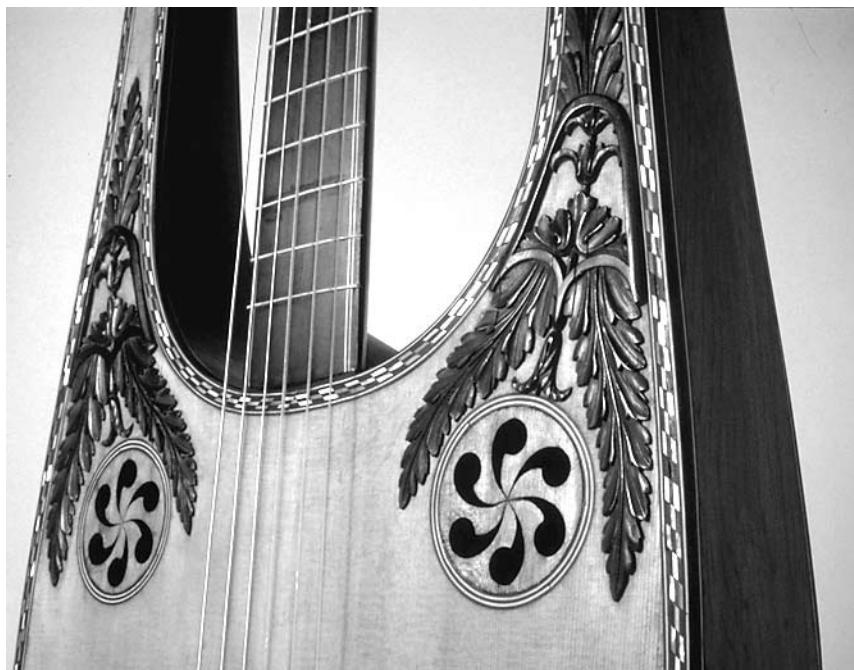
Figure 7. Detail of new roses and cast epoxy oak leaf branch (right).

3110 RTV silicone rubber. The mold was distorted to approximate the shape of the missing piece, and a replacement was cast using pigmented Epo-Tek 301 epoxy. The replacement was then trimmed to fit and set in place using Acryloid B-72. The replacement initially had a slightly glossy appearance in contrast to the rest of the oak leaf element. However, following a light application of wax, this difference in surface reflectance disappeared.

The discs for the roses were turned from European spruce, using a small jeweler's lathe. The discs were turned to the same thickness as the topwood, and rabbeted on the inside to match the sound-holes. The rubbing from the Boston guitar was, through the miracle of Xerography, reduced by approximately 15% to fit the smaller soundholes. The Xeroxes were then taped to the turned discs, the holes of the lobes cut with a brad-point bit, and the curves cut with corresponding gouges. The roses were then adhered in place using Acryloid B-72 and toned to match the top with Ciba-Geigy Orasol solvent soluble dyes. (fig. 7)

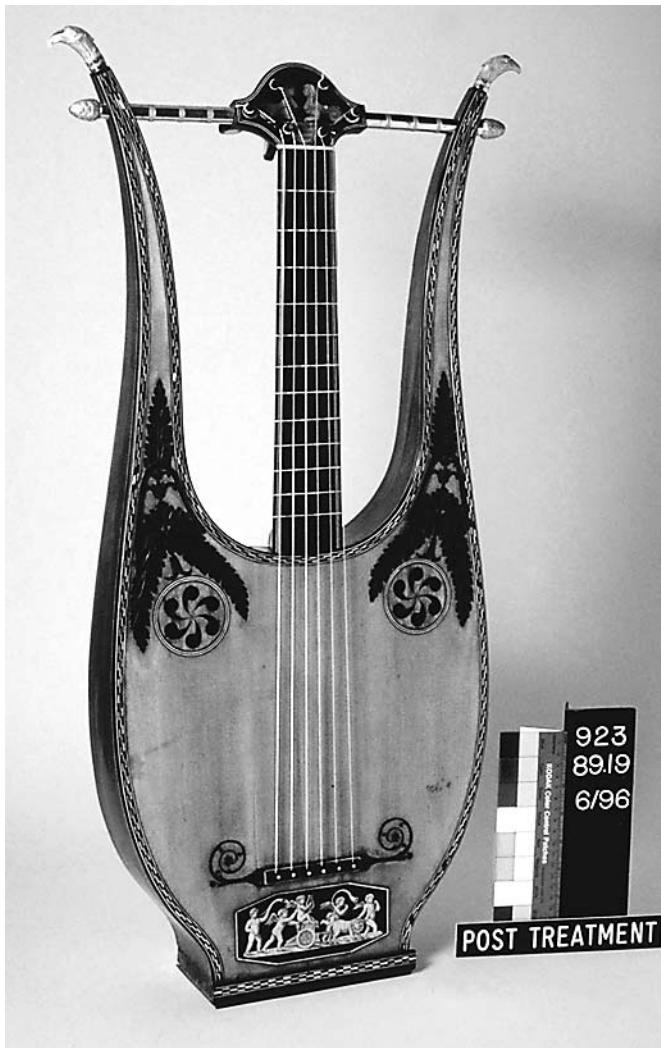
Figure 8. Instrument following treatment.

and Laurence Libin of the Metropolitan Museum of Art, concerning the question of playability. There is a unanimous feeling that the instrument should not be played. The addition of tuned string tension—approximately 100–120 lbs. of tension along the length of the instrument—would certainly have a distorting effect on the desiccated and brittle wooden material. Ultimately, the combination of string induced stress and handling while playing would result in the need for further conservation which can only reduce the value of the instrument as a document, something I have tried scrupulously to avoid in this treatment. Therefore, I put a set of period-style gut, silk and silver strings on the guitar, but only for the sake of appearance. They are arranged in such a way that only a light, straightening tension can be applied, and they cannot be tuned to pitch. (fig. 8)
