A Study of the Materials and Environment at Russel Wright's Dragon Rock

Susan L. Buck, Conservator, SPNEA Conservation Center

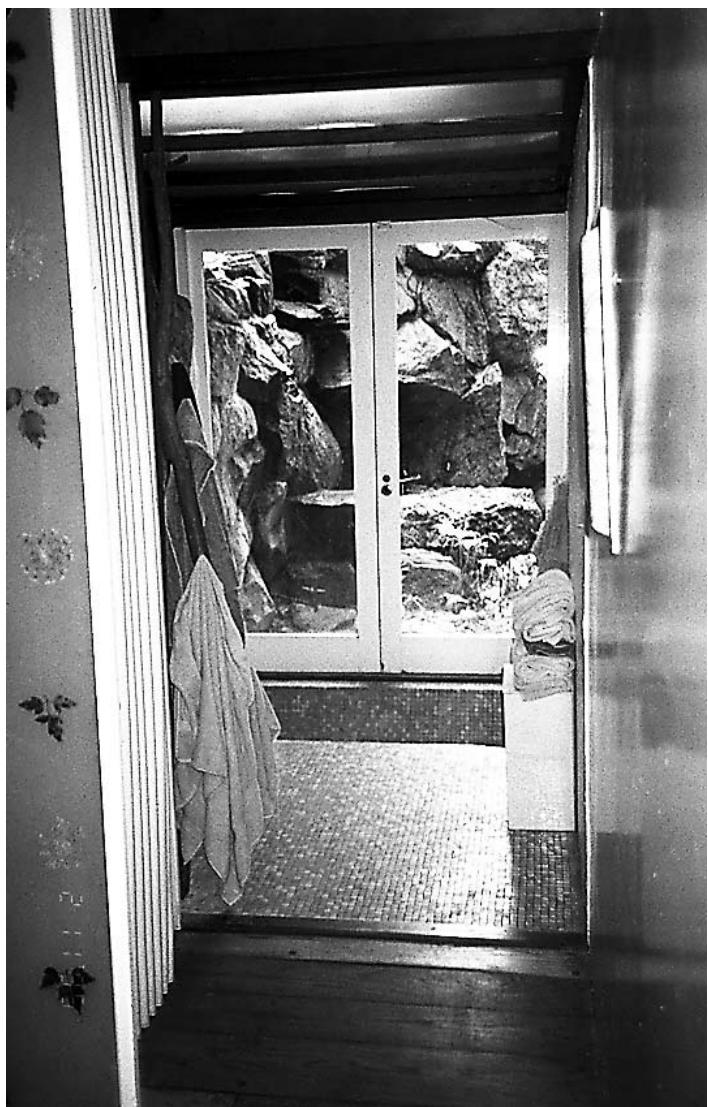
Figure 1. Sliding door panels, like this one leading into the Harem Bathroom, incorporate fragile plant materials from the site.

There is a very marked example of chronic light exposure when the sliding door in the Harem Bathroom is pulled completely closed. The butterflies sandwiched between the plastic at the leading edge of the door are embrittled, pale and faded from this outer edge to about one and half feet in. However, the butterflies sandwiched between the plastic panels at the inside section of same door are still brilliantly colored and remarkably intact. It appears that this door is most often left in a partially closed position which has caused the significant damage to the butterflies on the leading, exposed edge of the door.

4. Investigate methods to reduce the RH levels in the studio and to increase air circulation, to limit mold growth in this space.
5. Leave the panel with the butterflies in the fully retracted position as much as possible to limit light damage and vibration.

6. Investigate conservation methods to reattach and stabilize the fragile butterflies.
7. Develop guidelines for the care and maintenance of all finished surfaces. This would include designating the types of materials for use on woodwork (paste wax coatings only), restricting refinishing and repainting work in both the house

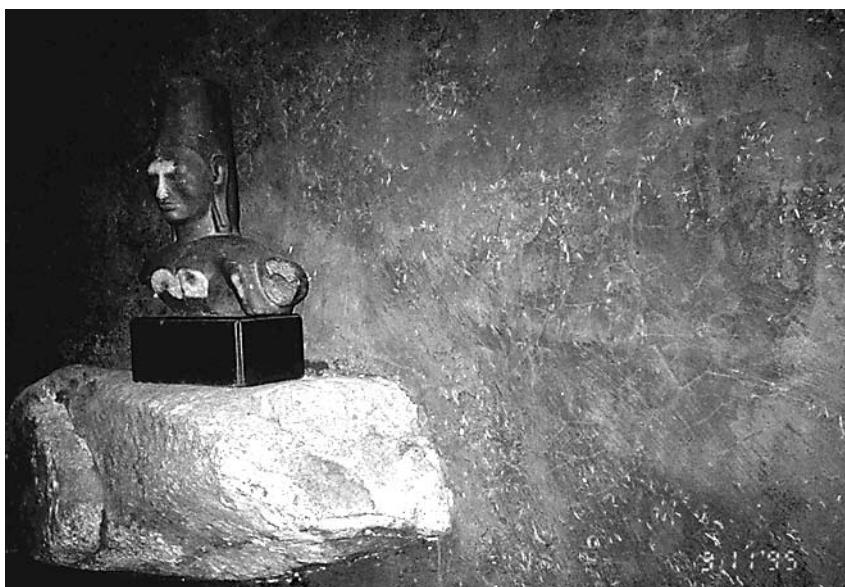
Figure 2. Russel Wright created textured green plaster walls in the living room by pressing pine needles into the pigmented plaster while it was still wet.

The green wall paints in the living room were identified as plaster colored with stable pigments, including lampblack, yellow ochre, and iron oxide. The green plaster also contains pine needles which were pressed into the plaster before it had set. The combination of lampblack and yellow ochre produces an optical green which is generally a darker, more olive green color. These are all stable pigments, in use since antiquity. The living room samples were analyzed with FT-IR microspectroscopy and confirmed to be plaster with pigments (based on the presence of double peaks for CaSO_4 and CaCO_3 and the absence of peaks for any organic binders), as described by Wright.

One sample was taken from an area of efflorescence on the west wall where salts have been deposited on the surface by water wicking out through the plaster substrate and the textured green plaster. This water carries soluble salts from the plaster which then dry on the surface leaving a powdery white deposit. The plaster substrate and the green plaster finish layers are particularly friable in this area.

1. Investigate and correct the sources of moisture traveling through the living room green plaster and the stucco-like paint in the hall.
2. Determine the best methods for shielding the most vulnerable areas of the house and studio from excessive visible and UV light exposure. Install UV blocking materials as soon as feasible, and install light-reducing shades where possible.

3. After the moisture problems in the walls have been identified, test alternative methods for consolidation of the flaking plaster and peeling stucco-like paint in the living room and hallways.

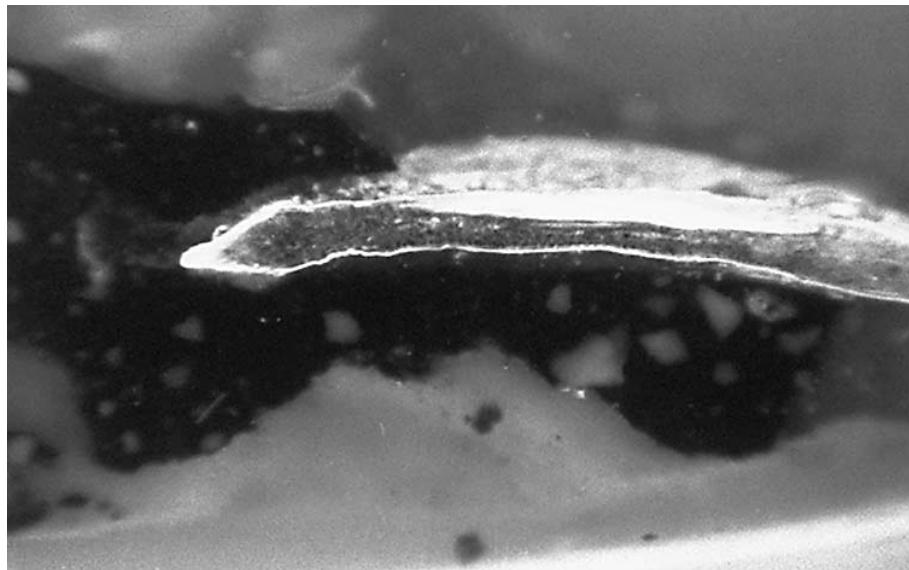
Figure 4. This cross-section shows a pine needle partially embedded in the green plaster above a more traditional white finish plaster. **Above:** UV light. **Right:** Visible light.

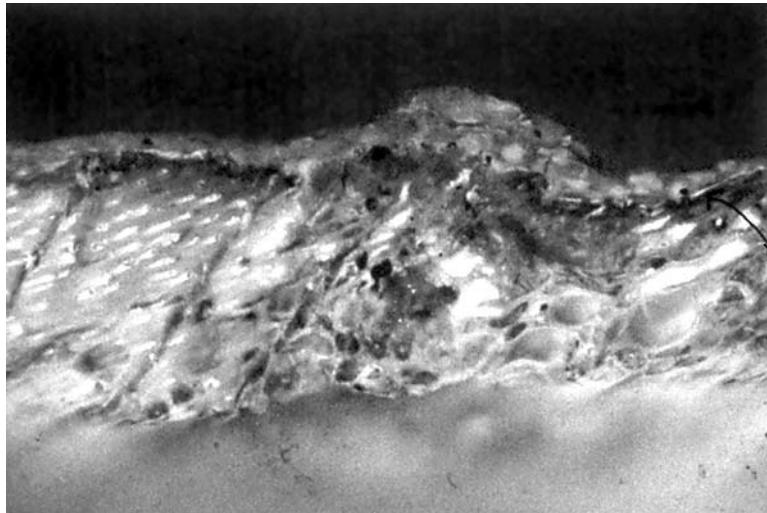
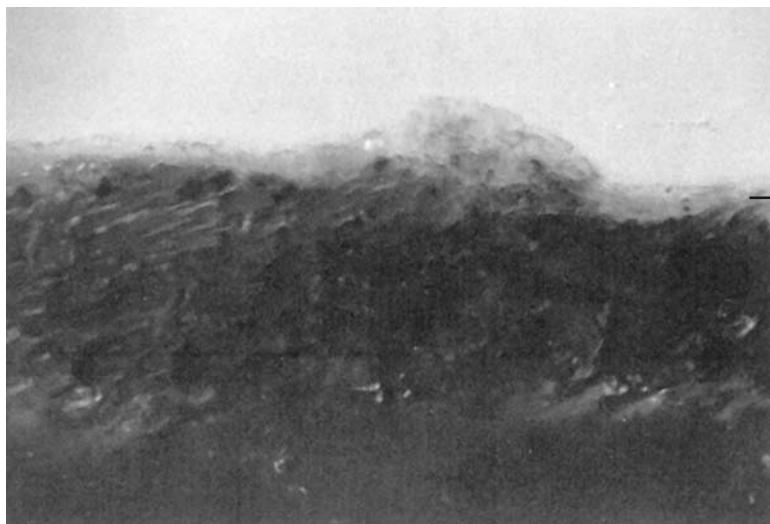
The studio woodwork has the same type of slightly pigmented/flattened synthetic resin found on the woodwork in the main entry, the main hall, the Harem Bathroom and on the top of the kitchen table. However, this flattened varnish is the second generation in the studio as there are remnants of an earlier sealant or plant resin varnish coating trapped in the fibers of the wood. The Wrights moved into the completed studio while work on the house was progressing, so this second matte finish layer was perhaps applied at the same time Wright was applying woodwork finishes in the house. Or, perhaps he first tested out this coating in the studio before using it in the house.

May be remnants of an earlier varnish coat (bright white auto-fluorescent material)

Clear finish coat with pigments and flatteners suspended in it.

Figure 5. A synthetic varnish with flatteners was used on the wood surfaces in the studio and house to create a natural, matte appearance, but still provide a protective, washable surface. Top: UV light, bottom: visible light
