# After the deluge: The conservation of two Chinese chests

Kathy Z. Gillis, Assistant Objects Conservator, Virginia Museum of Fine Arts, Richmond, Virginia

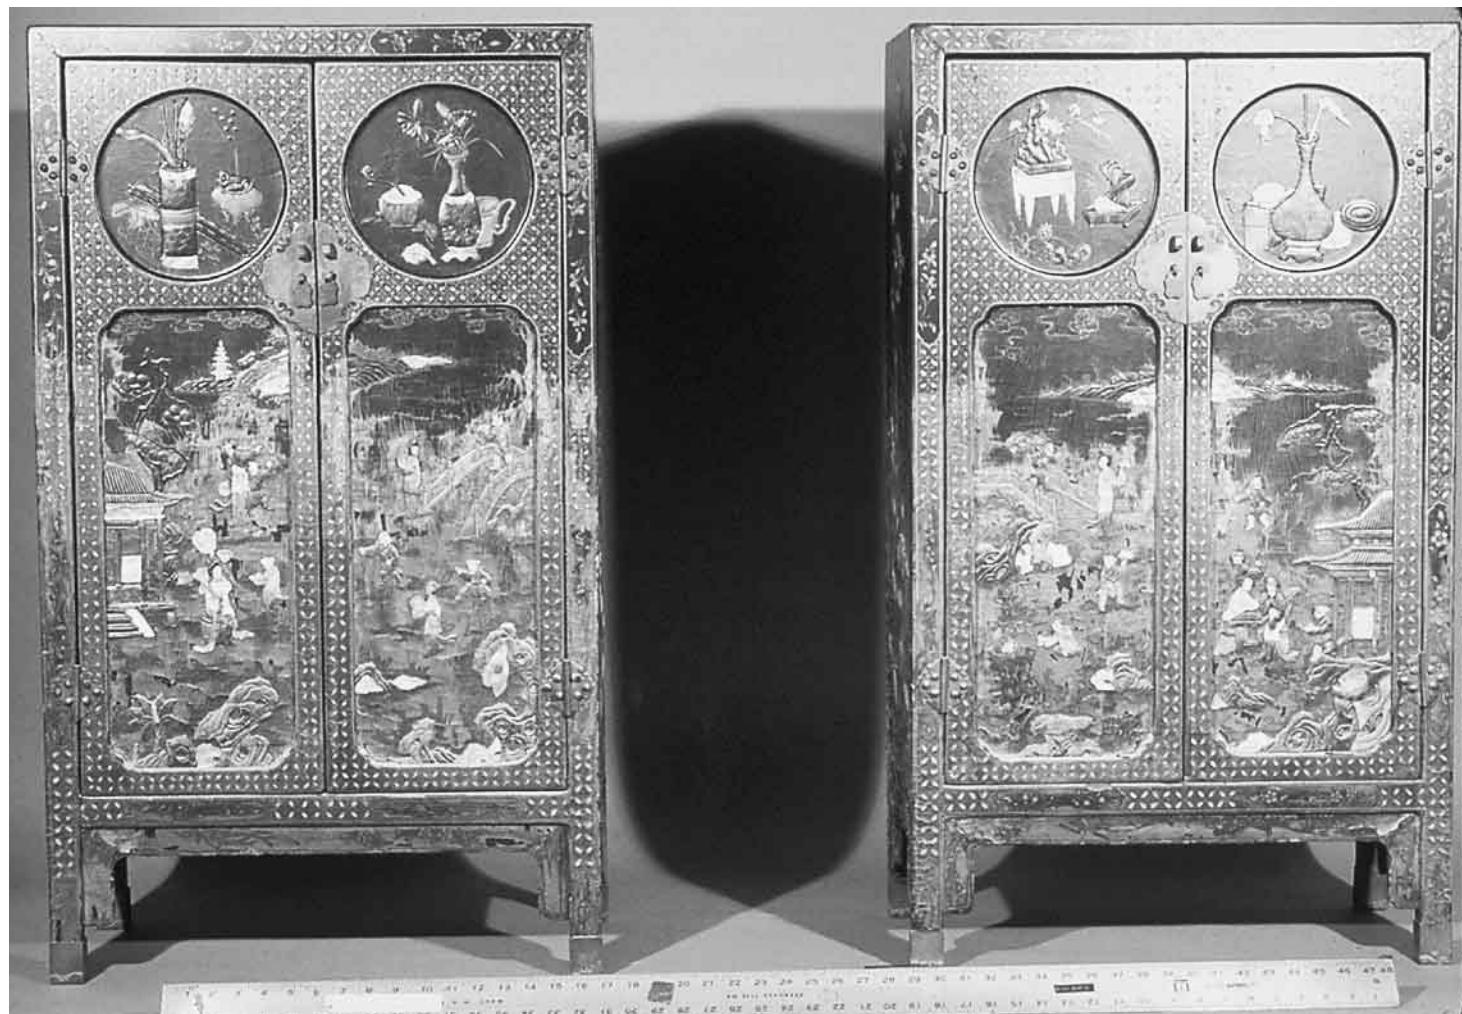
Figure 1: Before treatment, Chest "A" and Chest "B"

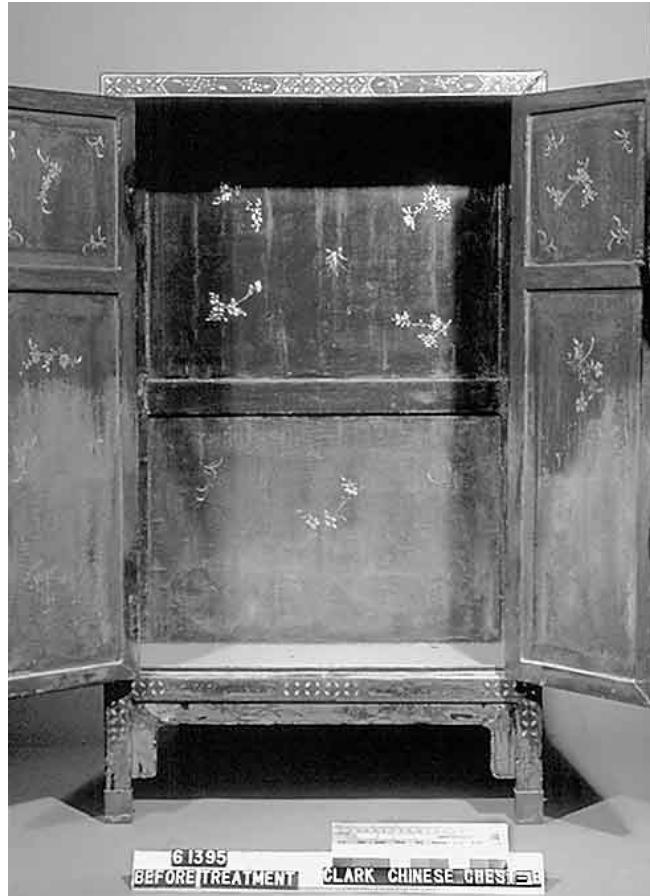
Both the exterior and interior surfaces were affected. (fig. 2) On the interior, the coating was blooming, but not actively flaking. The exterior varnish, however, was delaminating from the lacquer. Surprisingly little damage was evident in the wooden structure under the lacquer. The lacquer coating seemed to act as an excellent water barrier. The wooden and ground components under the lacquer were only damaged in areas where there was previous structural damage to the legs of one of the chests.

Figure 2: Before treatment, Interior, Chest "B"

The interior coating and the back of the chests responded more easily to testing for resolubilization and evening out, and therefore did not necessitate complete removal. This option was preferred on the interior, since the décor was on top of the varnish. A 50:50 solution of acetone and ethanol was used for this resolubilization. Some severe areas of blanching inside the chests were removed by swabbing with pure acetone. These areas fortunately did not hold any decoration (fig. 6).

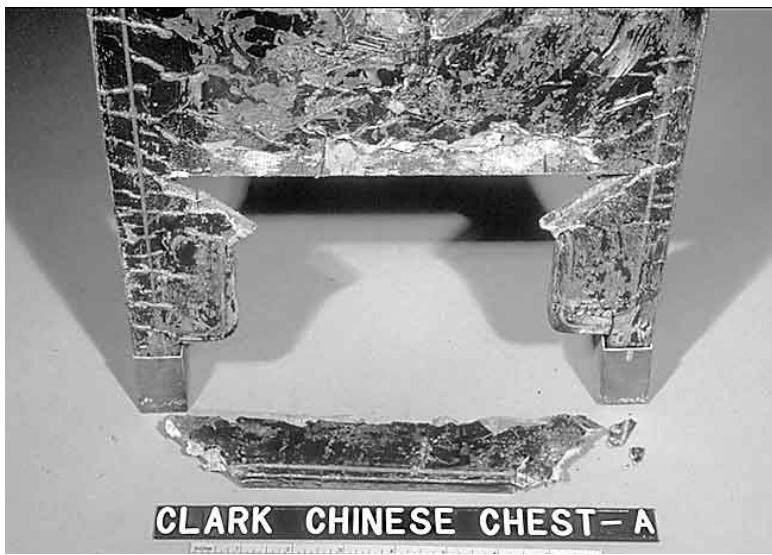
**CLARK CHINESE CHEST-A**

This was the case for one of the patients (Chest "A") where a portion of the material between the proper left legs had been detached. (fig. 3)

The corresponding areas on the front and proper right side of the chest and both sides of Chest "B" were split at the joins and were subject to movement. The substrate wood, however, appeared to be in stable condition, with most of the damage occurring to the varnish and lacquer layers.

*Figure 3: Before treatment, structural damage to Chest "A" proper left side.*

The detached piece from the bottom proper left side of Chest "A" was reattached to the chest using hot hide glue and Acryloid B-72 acrylic resin in acetone. Loose pieces of wood around the legs and the top front moldings on the interiors of both chests were secured using hot hide glue. Areas of flaking lacquer, areas of loss, and areas adjacent to losses were consolidated using solutions of Acryloid B-72 acrylic resin in acetone. The concentrations of resin-to-solvent varied from 20% to 30%.

The losses around the detached piece were filled using a wax-resin mixture (polyvinyl acetate AYAC, ethylene acrylic acid copolymers A-C 540 and A-C 580, and an antioxidant, Irganox 1076). This fill material had been used with good results and undergone testing over a number of years by John Burke, Chief Conservator at the Oakland Museum, as well as other conservation professionals. A barrier coat of polyvinyl acetate AYAC was applied to the surfaces to be filled. The fill material had good adhesion to the barrier layer, was easily sanded with acetone, produced a sheen similar to the lacquer, and was easy to control. Color matching proved to be the biggest challenge, since dry pigments had to be added to the wax-resin mixture during its preparation. Since the color of the lacquer was not completely uniform, it was difficult to achieve a match that was suitable in all areas of loss. The wax resin was heat-set into place and

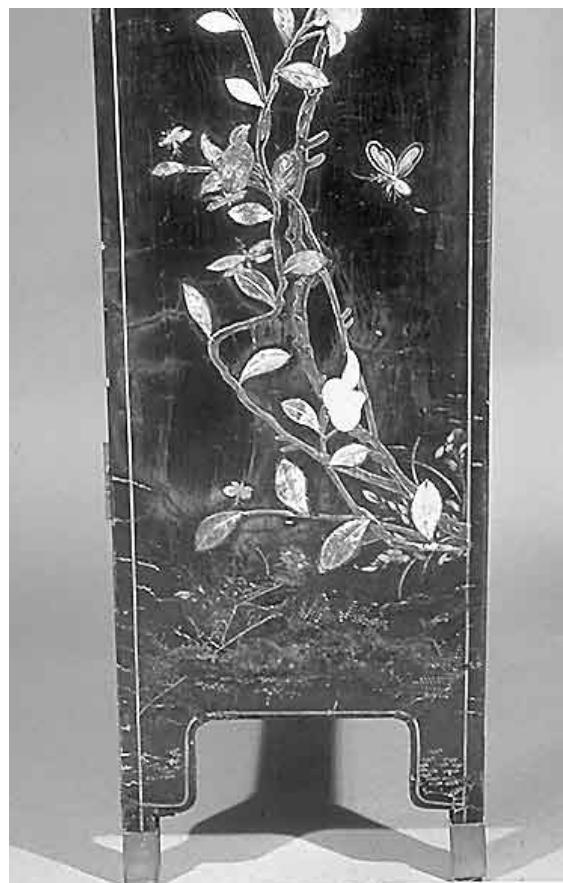
*Figure 4: After treatment, area of loss on Chest "A"*

solvent-polished using acetone on cotton swabs. Additional smaller areas of loss on both chests were filled using this mixture and/or pigmented wax. (fig. 4) Subsequent to this treatment, information about this fill material was published in the Spring 1997 *Journal of the AIC*, in an article by Susanne Gänsicke and John W. Hirx, entitled "A Translucent Wax-Resin Fill Material for the Compensation of Losses in Objects."

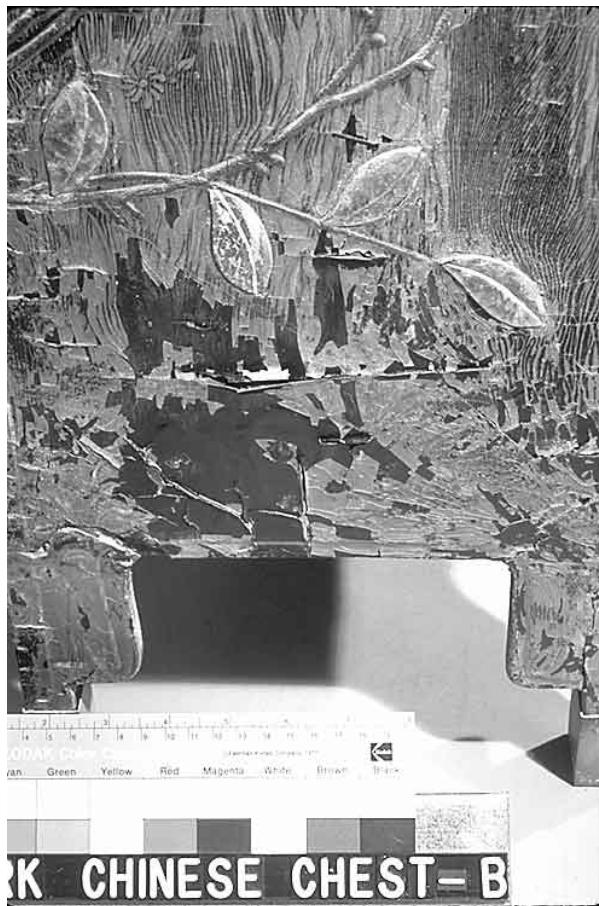
The exterior varnish layer, which was actively flaking, was soluble in acetone, fluoresced yellow-green under ultraviolet (UV) illumination, and burned rapidly, indicating the likelihood of a cellulose nitrate-based coating. Under UV examination, it was also apparent that the existing coating had been sprayed on, without removing the hard-

Figure 5: Detail of flaking varnish, Chest "B"

Although testing was carried out for the feasibility of resolubilizing the varnish, in many areas, the varnish was literally falling off in large sheets. (fig. 5) Much of the varnish, therefore, could be easily removed mechanically, and wooden applicators, microspatulas, and Teflon spatulas were used in this phase of the treatment. On the exterior of the chests, varnish that did not pop off easily was removed using acetone on cotton pads and swabs. The coating on the upper third of the chests, where the varnish had not been affected by the water, was also removed using acetone. This was done

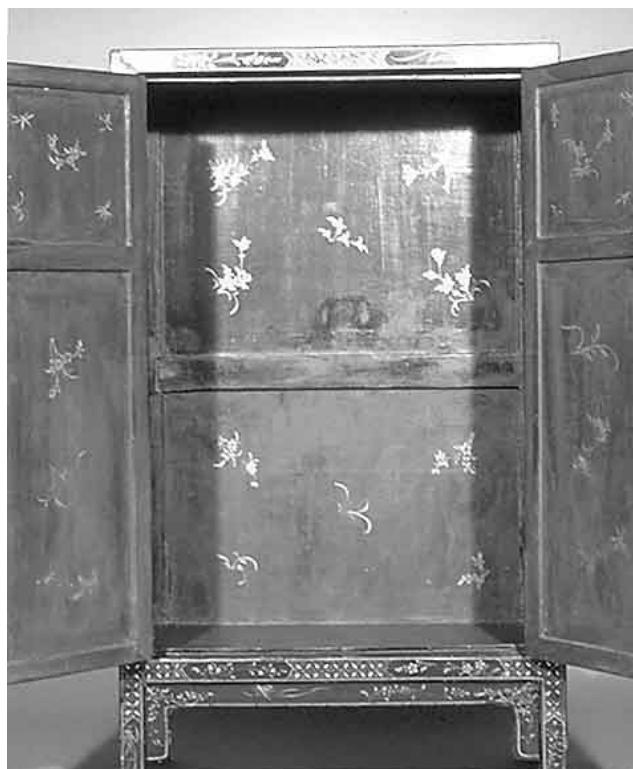
Figure 6: After treatment, Interior, Chest "A"

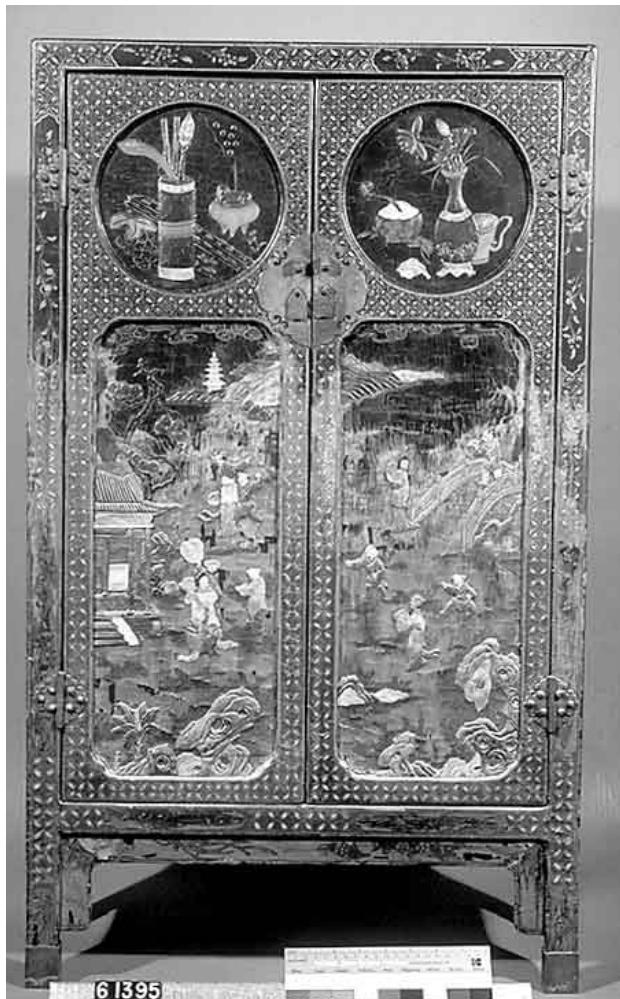
Figure 7: Before treatment, Chest "B"

The areas that had not experienced flaking varnish on the upper third of the chest did not change appreciably in appearance as a result of the treatment. The remaining areas, however, did change. (figs. 7 & 8)

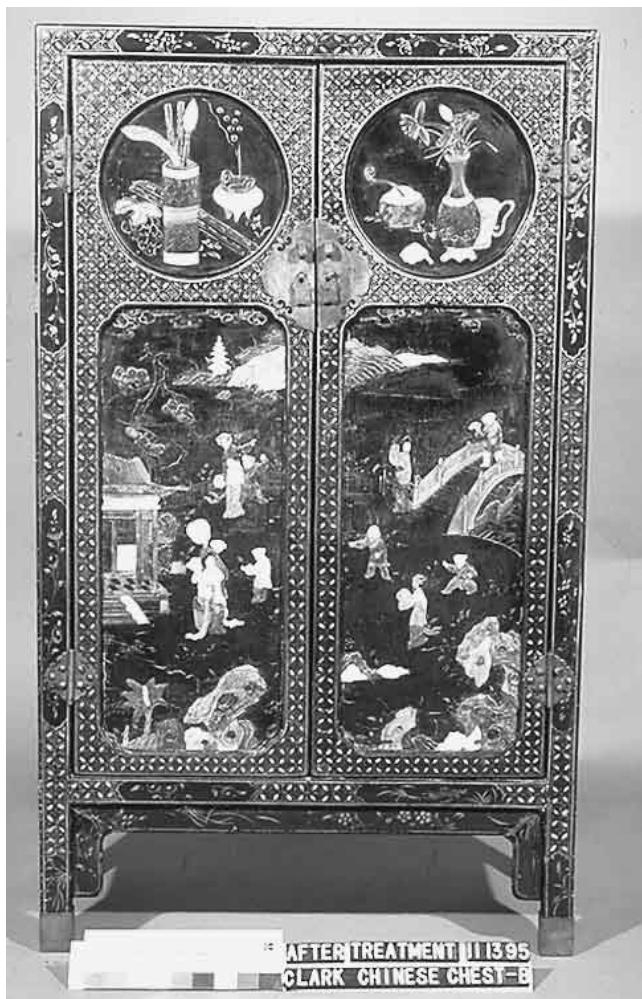
Figure 8: After treatment, Chest "B"

sen was polycyclohexanone resin (Larapol K-80) in Stoddard and toluene. Irganoz 1076 was added to this mixture to hinder cross-linking of the resin. This coating could be brushed over the exterior lacquered surfaces providing a thicker coating than the previously sprayed varnish. Larapol was also applied to any interior surfaces where blanching varnish had been removed. We wanted a coating that could be removed with solvents other than acetone so that the coating we had applied could be distinguished from the acetone-sensitive coating that had been resolubilized on the interior. In addition, all exterior surfaces were then waxed using Renaissance Wax to add an additional moisture barrier.
