# The Deinstallation of a Period Room: What Goes in to Taking One Out

*Gordon Hanlon, Furniture and Frame Conservation, Museum of Fine Arts, Boston*

*Melissa H. Carr, Masterwork Conservation*

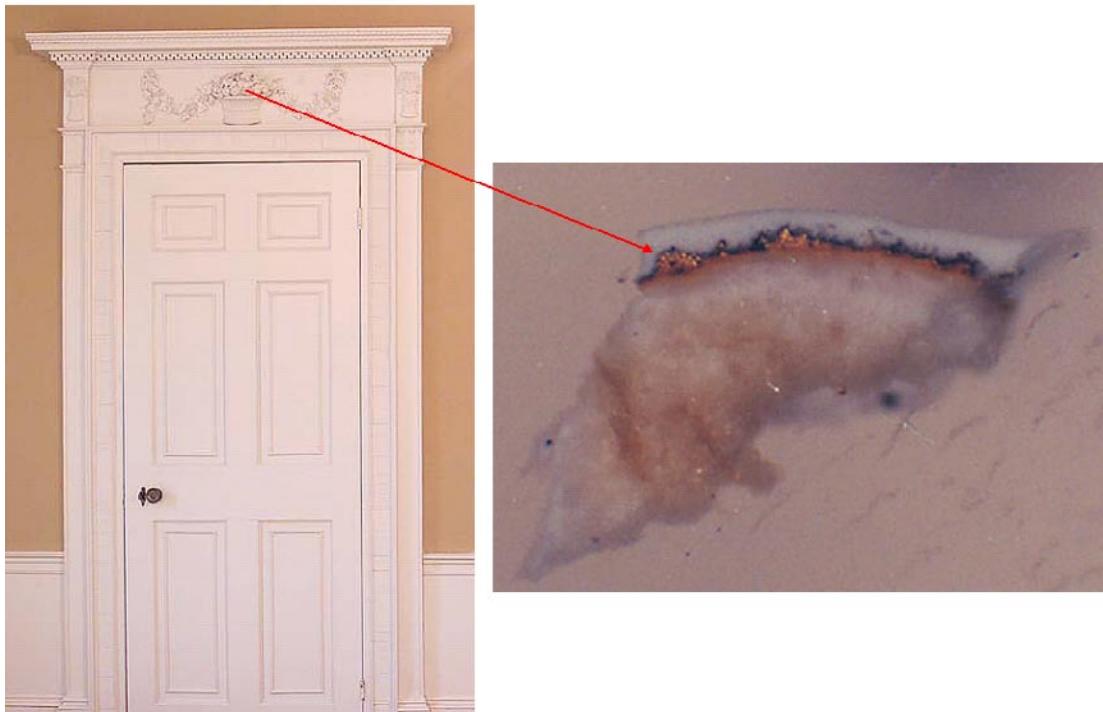
Figure 4. Cross-section revealing gilding beneath white paint in Oak Hill bedroom.

history of multiple paint layers but in one room we were pleased to discover that some of the over-door carving had originally been gilded (fig. 4).

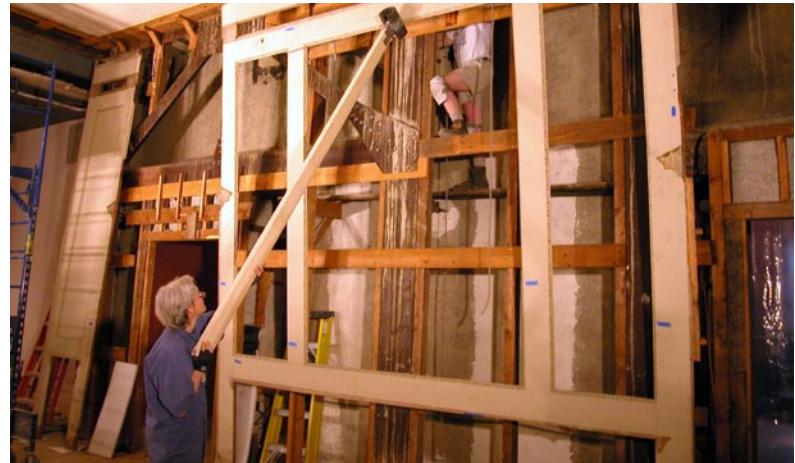
Figure 6. Frame on wall D being lowered to the floor.

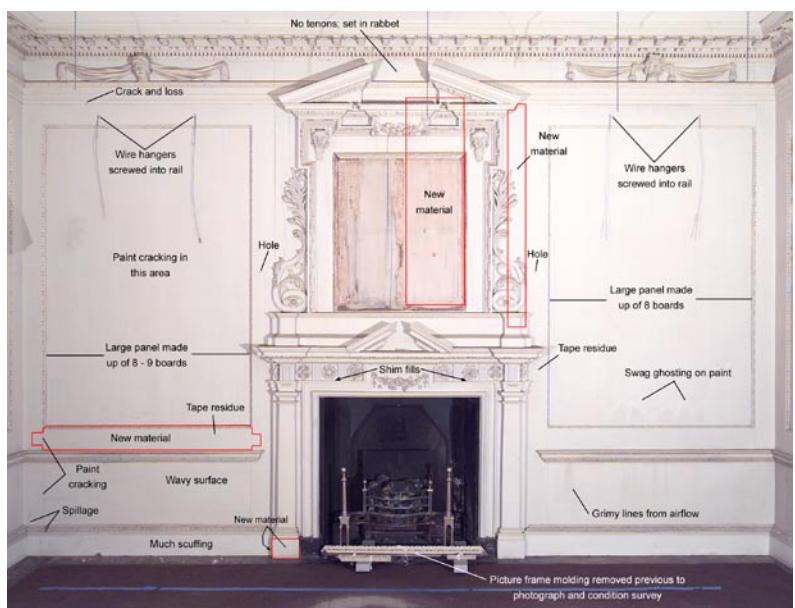
Before the room was deinstalled, a limited description and condition report was prepared based on visual inspection. Notes on the walls, floor, ceiling, doors and surrounds, windows and hardware were recorded, and elevation photographs of each wall were used to illustrate the notes. Obviously new material (inserted in the 1930s installation) was indicated (fig. 7).

Figure 7. Wall A condition survey image.

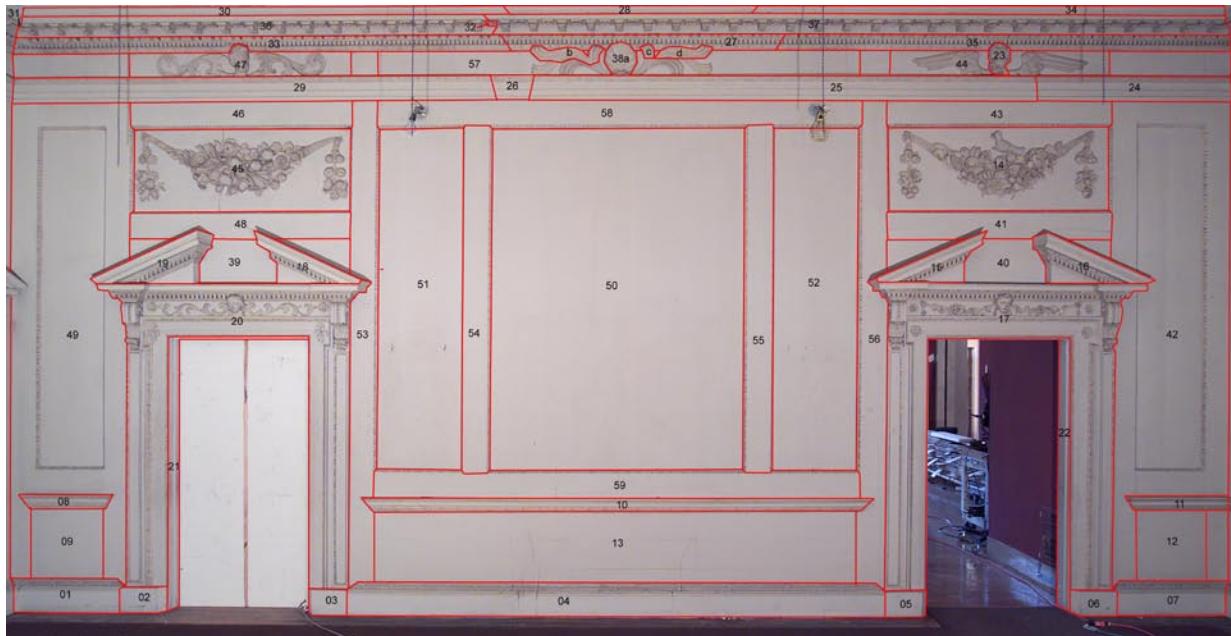
Figure 9. Wall D final catalogue image.
