COUNTERACTING WARPAGE IN WOODEN OBJECTS: TWO NEW APPROACHES

F. Carey Howlett, Conservator of Furniture, The Colonial Williamsburg Foundation, Williamsburg, VA 23187

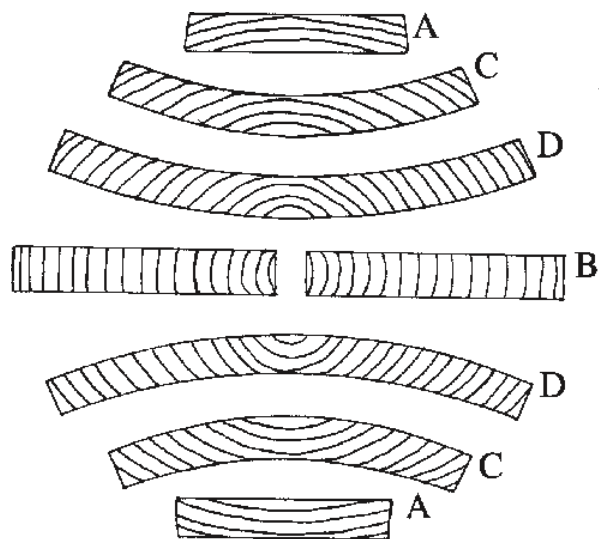
Figure 1. The characteristic cross-grain shrinkage of wood as it dries from the green state, exaggerated for illustrative purposes. Tangential-sawn boards (A—parallel to the growth rings) shrink approximately twice as much as radial-sawn boards (B—perpendicular to the growth rings). Plainsawn boards (C, D) are neither purely tangential or radial in character, so they shrink unevenly—cupping toward their tangential faces.

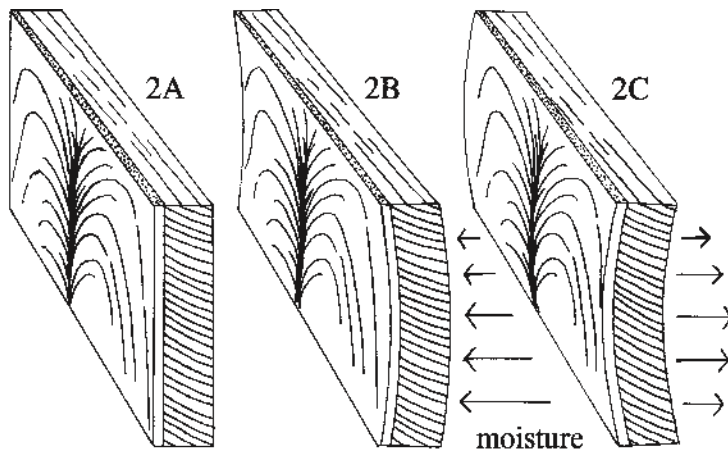
Figure 2. A veneered or painted panel undergoing compression set shrinkage. 2A: a newly-constructed flat panel, with a veneer or paint “moisture barrier” on the presentation surface; 2B: the absorption of moisture by the unfinished reverse surface, with swelling impeded by the stable presentation surface; 2C: as moisture evaporates, the compressed reverse surface shrinks to a smaller dimension, and a permanent warp appears.

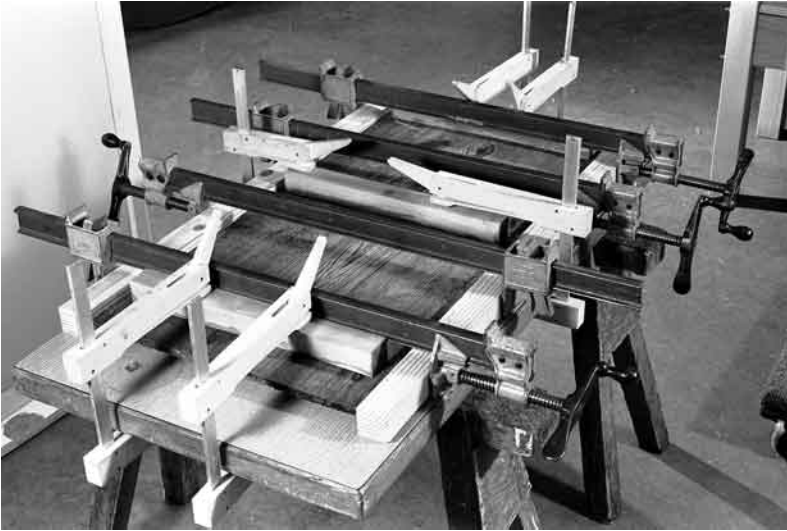
Figure 3. Inducing compression set shrinkage in the convex side of a warped yellow pine board (Case Study 1). With the water-saturated convex side facing up, cam clamps apply light downward pressure on the warp while optional bar clamps restrict cross-grain expansion.

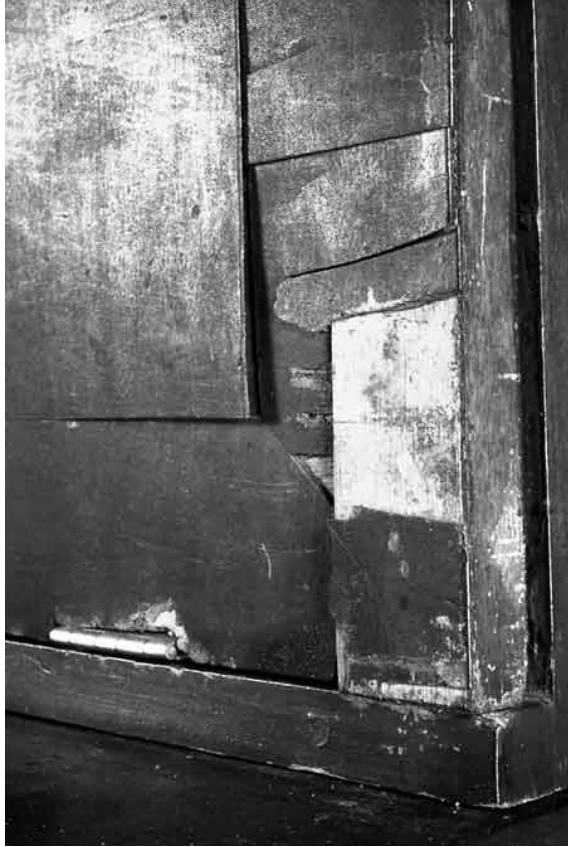
Figure 5. Close-up of a projecting batten and associated veneer damage on the warped fallboard in figure 4, before treatment.

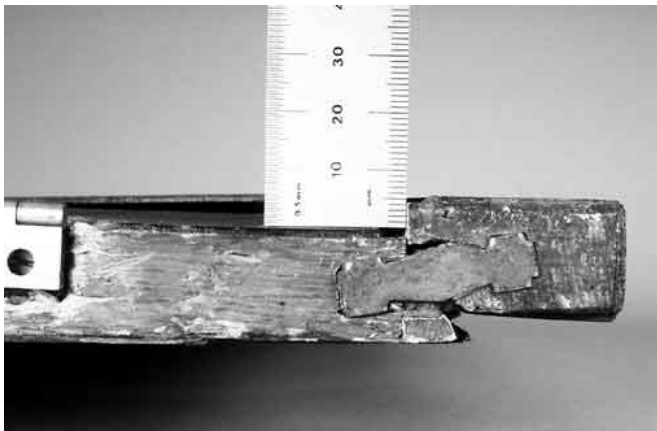
Figure 6. Edge view of the projecting batten in figure 5, significantly out of plane with the warped pine fallboard before treatment. A handyman made a vain attempt to realign the parts with a strap-nail.

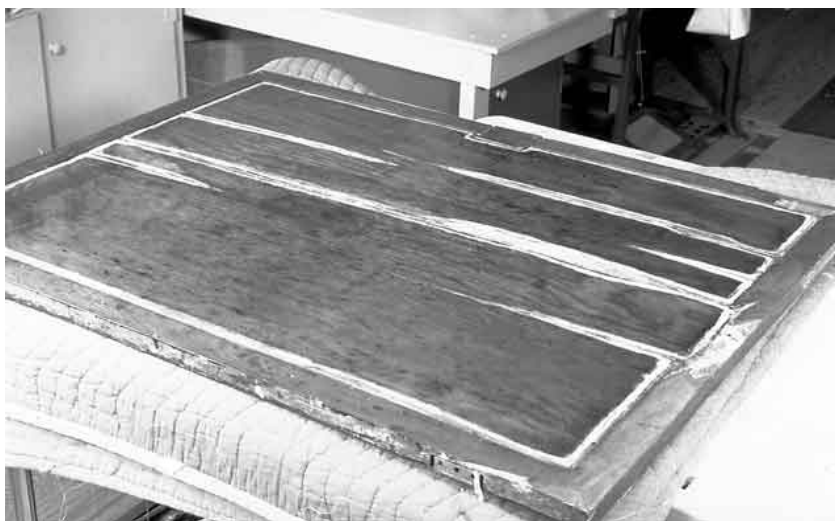
Figure 7. Treating the writing surface of the fallboard with a glycol/water solution (Case Study 3). Paraffin dams prevent the solution from wetting the veneer edgebanding or entering the splits.

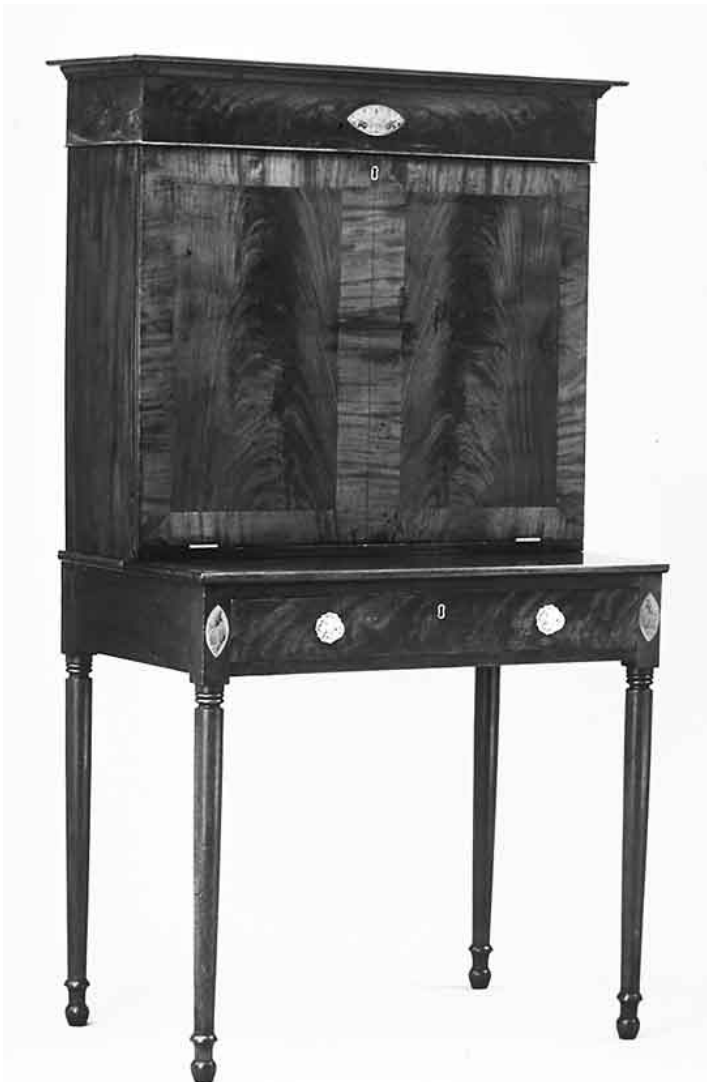
Figure 8. The writing table and bookcase (Case Study 3) on exhibit following treatment. The object is exhibited closed at all times: the treated writing surface on the interior remains bare to permit monitoring.

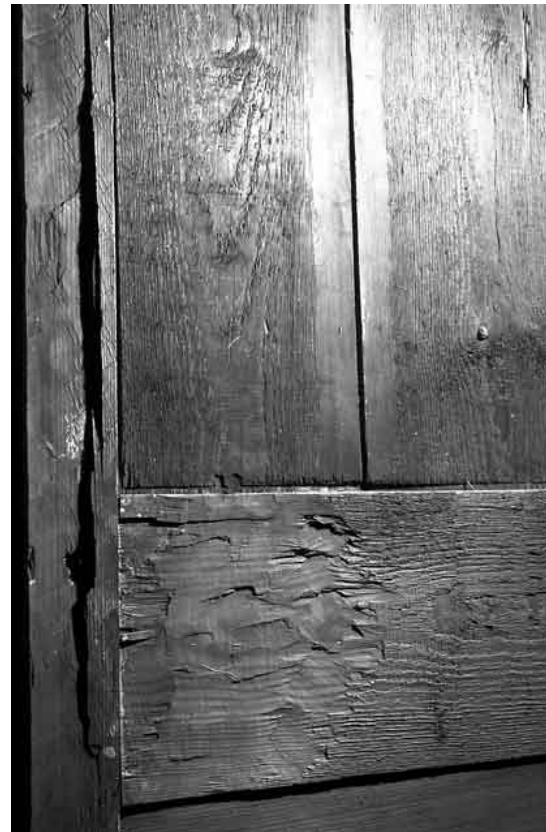
Figure 10. *A close-up of damage on the reverse caused by the force of the warping panel (Case Study 4). The stile and rail were initially weakened by early adze cuts which provided chimney clearance for the panelling.*

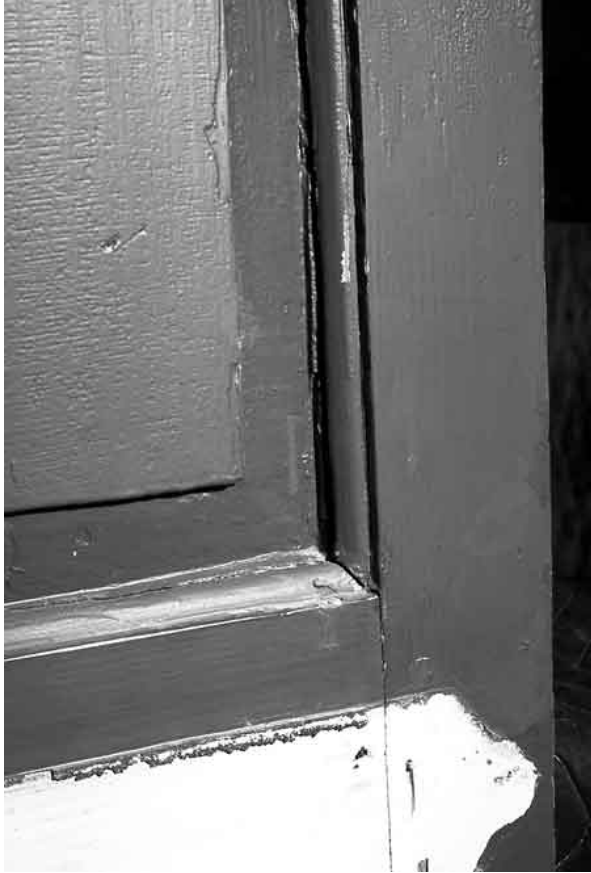
Figure 11. The face of the painted panel opposite the damage illustrated in Figure 10. A large, tapered putty fill bridges the gap between the warped panel and the rail.

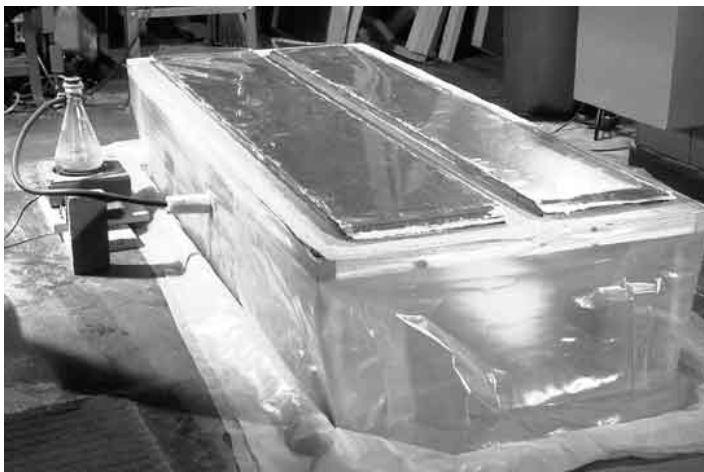
Figure 12. Beginning treatment: swelling the concave sides of the warped boards from the panel with steam using a humidity table (Case Study 4).

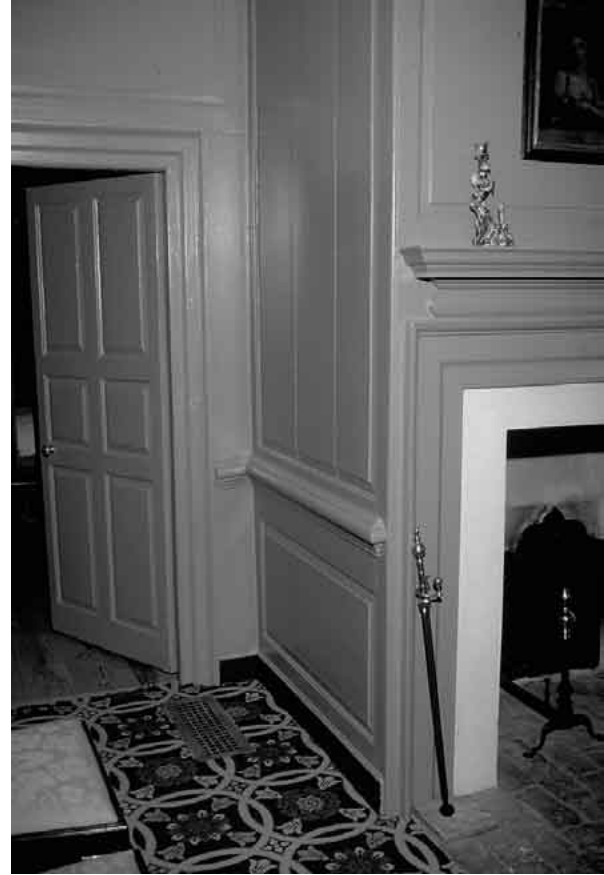
Figure 13. A view of the treated panelling, reinstalled on the left face of the parlor chimney breast at the Brush-Everard House (Case Study 4).
