A Passive Approach to Practical Climate Control

Jennifer Baker and Fred Lugano

Introduction

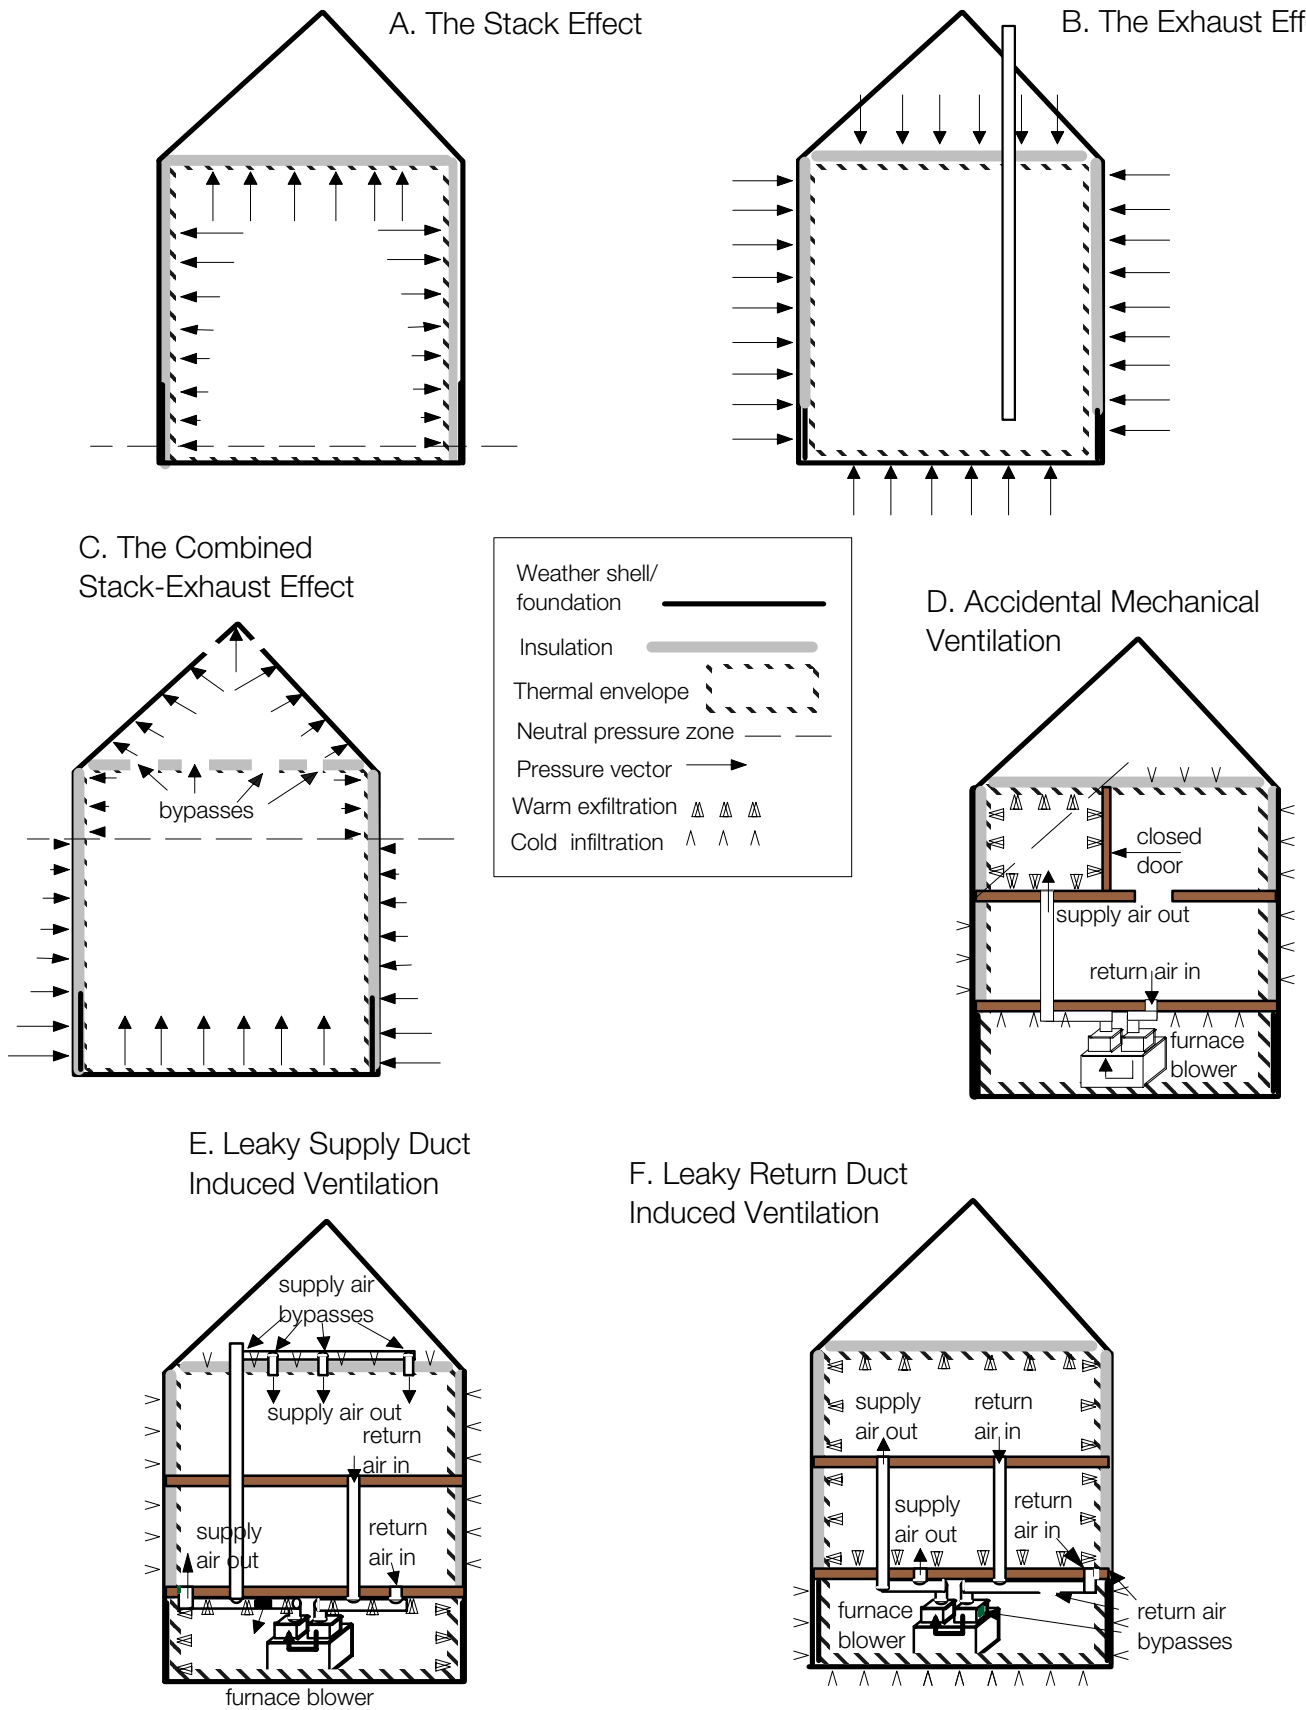
Figure 1: Common problems that reduce the effectiveness of the thermal envelope.

However, in a building with any sort of exhaust, indoor air is forced out (*Fig. 1B*). Outdoor air is drawn in to replace it. This applies a uniform negative pressure to the entire envelope, which is bad. An exhaust can be any number of intentional or accidental sources from mechanical blowers such as a range hood, bath fan or clothes dryer, a combustion flue, such as a furnace, hot water heater, fireplace or wood stove, or simply a pressurized hole, such as a plumbing vent, chimney chase, wiring penetration, partition top plate, sloped ceiling, balloon framing, extended framing, stair well, attic hatch or fan grill.

Figure 1C represents a leaky building. The house is full of pressurized holes. The holes in the air barrier at the top of the house allow heated air into the attic. If there is any attic insulation, it is now hanging between two heated spaces and is doing nothing. This has several negative effects on the building. First, the neutral-pressure plane, the point at which everything above is under positive pressure and everything below is under negative pressure, has risen so that a large part of the house is now under negative pressure. This part of the building will be drafty, subjected to raw, outdoor air and harder to maintain a stable climate. If the interior air is intended to be filtered at the intake, the infiltration may allow more air in than through the intended mechanical ventilation intake. This will induce a significant air conditioning load (heating or cooling). Meanwhile, large amounts of expensively-heated and possibly humidified air is now pouring into the attic, a very bad place for it. If the attic is vented, the vents act as an exhaust to outdoors, increasing the stack effect. This results in condensation in the attic, and the heated roof deck will cause damage from ice dams. An HVAC system designed to induce positive pressure, a common specification in historic houses, will be in an uphill battle against this building shell. Consequently to be successful, it will have to be oversized, two to four times, which will consume more energy, and over-pressurized, which can drive humid indoor air into wall cavities, causing more damage.

The HVAC system and ductwork itself can increase these problems further (*fig. 1D*). It is quite common in old houses to have far fewer return ducts than supply ducts, or to use building cavities as the return ducts. Without a balanced system, localized pressures can develop, creating spots of damage that are sometimes hard to understand, and building performance will deteriorate.

Leaky ducts or ductwork that is poorly located, is another major problem (*fig. 1E*). In this diagram, the supply ducts are located in the attic, outside the thermal envelope, another common historic house retrofit and a fundamentally bad idea. When these ducts leak, and they always do, they send large amounts of expensive heated air into the attic. Since ducts are pressurized, the effect of even

One last example: When return ducts leak in the cellar (*Fig 1F*), or if there are not enough of them, bad things can happen throughout the entire house. It can become over pressurized by the heating system, driving warm, moist air into the walls and attic, soaking the sheathing and siding, and causing peeling paint, rotting framing, condensation and ice dams. Mechanically induced negative pressure in the cellar will also contaminate the indoor air with poisonous combustion and soil gases.

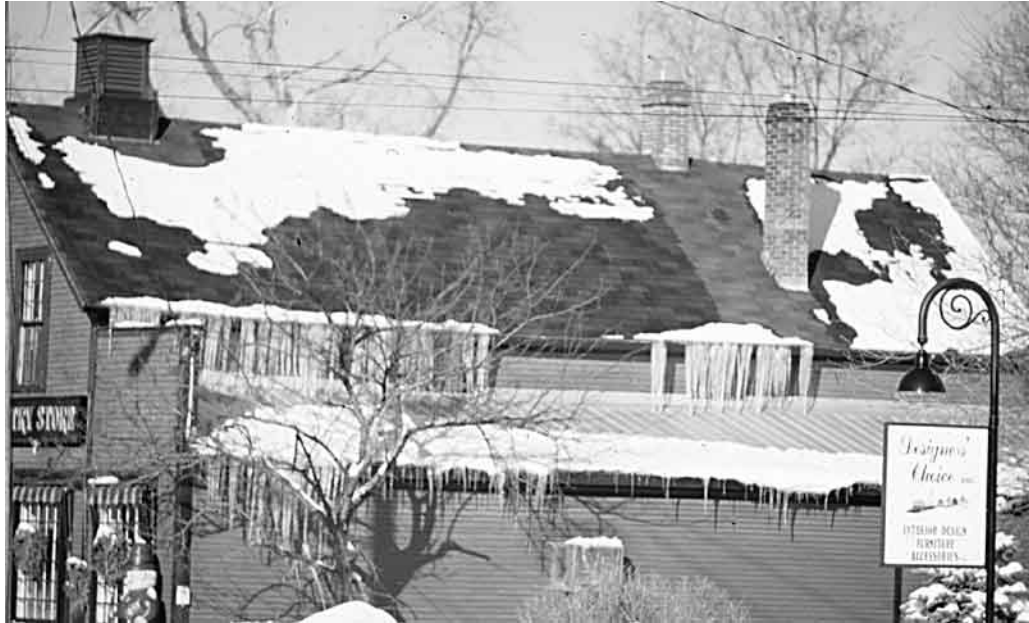
Figure 2: When the snow on a roof melts much more quickly than on those of surrounding buildings, it is evidence of large amounts of heat loss.

While some building defects might be difficult to track down, under the right conditions, others can be spotted from a moving car at 50 mph. In cold climates, the appearance of melt patterns on roofs, impressive icicles and ice dams (*fig. 2*) are striking visual manifestations of large air leaks. Ice dams are not an inevitable consequence of having gutters; and are not caused by not enough attic venting. They are caused by large amounts of heated air escaping into the attic through bypasses in the thermal envelope.

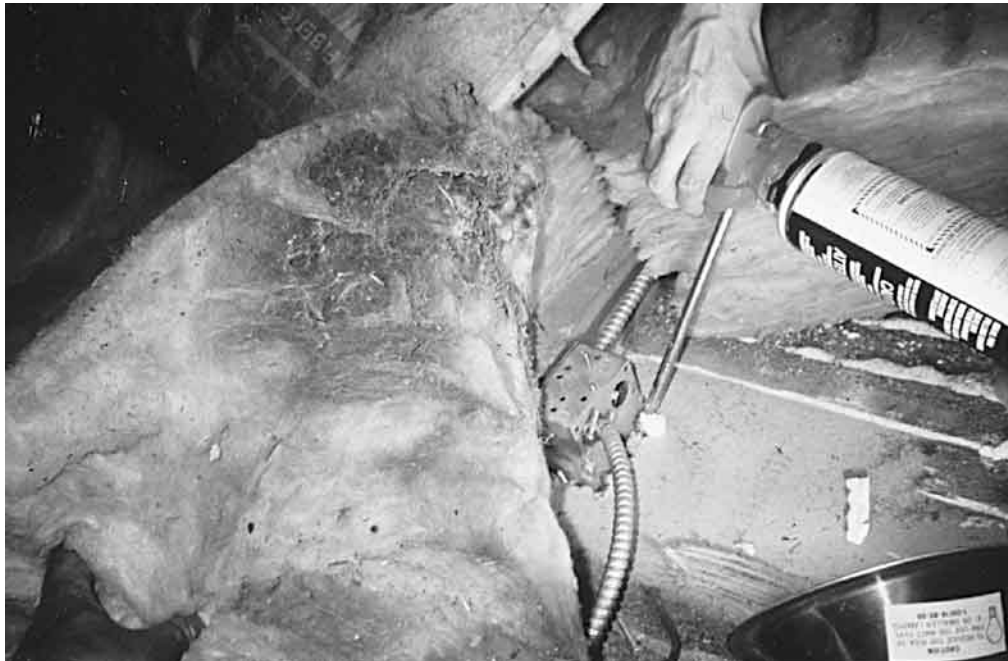
Figure 3: The dirty, stained fiberglass around this electrical fixture indicates that a large volume of air is moving past this spot. The fiberglass acts as a filter, trapping the dirt, much as fiberglass furnace filters do.

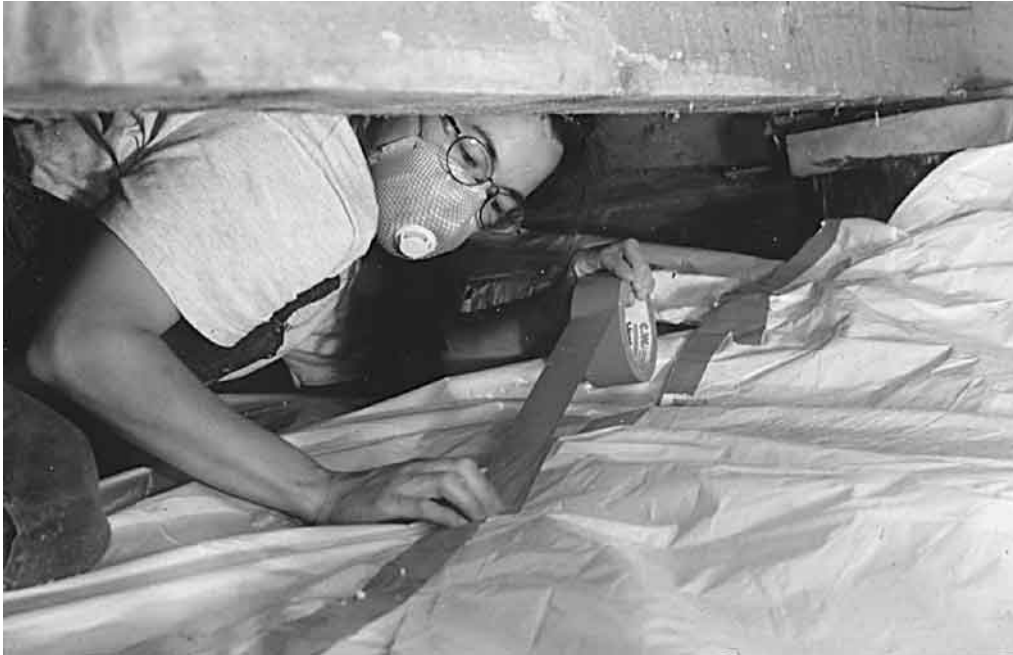
Figure 5: Laying Tu-Tuf, a cross-linked polyethylene sheeting, in a crawl space. Tyvek tape works well for taping edges together.

Therefore the first step in improving a thermal envelope starts in the cellar. All dirt floor surfaces, including crawl spaces (*fig. 5*), must be covered with a plastic membrane. In most cases, a cross-linked polyethylene sheeting such as Tu-Tuf, is preferred over standard polyethylene sheeting, because it is more durable and compatible with adhesives. In an area that receives regular use, an EDPM (ethylene-propylene-diene monomer, a roofing material) membrane can be used for even more durability. Depending on the building and the moisture load in the cellar, it may be necessary also to cover cement slab floors or the walls. Walls can be covered using a water-based contact or polyurethane adhesive to adhere the plastic.

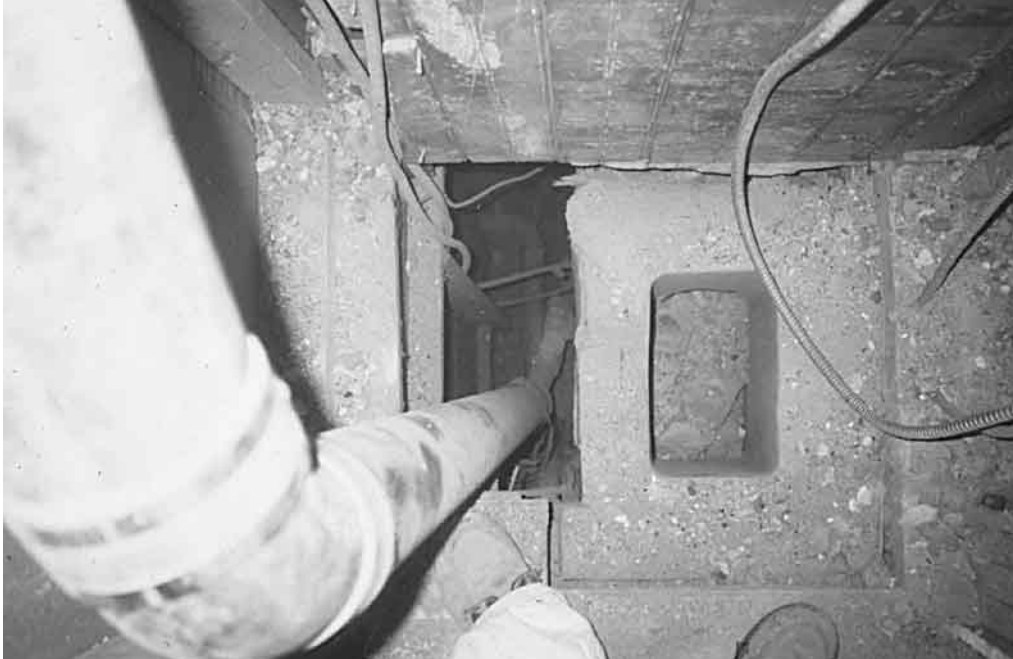
Figure 6: Plumbing chases can be large, problematic holes in the thermal envelope.

are most commonly found around chimneys, plumbing vents, staircases, recessed lights, ductwork and electrical bypasses (*fig. 6*). This is also why the attic door should be the tightest door in the house, not what they usually are, either a thin hatch, a flimsy pull-down attic stairs mounted on 1/4" plywood, or a standard interior closet door.

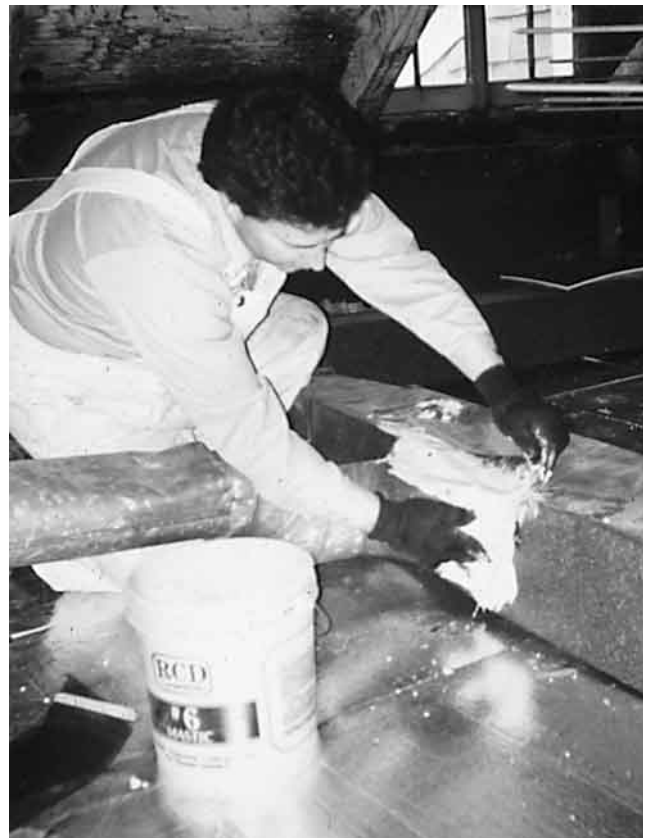
Figure 7: Sealing a duct with duct mastic.

When ducts are accessible in the cellar and attic, they can be sealed using a water-based duct mastic (*fig. 7*). Holes can be covered using mastic and screening. Duct tape should never be used to seal ducts, as it doesn't last. Duct leaks in the attic and cellar are the most important ones to fix. Some times a building just uses the building cavities as return ducts. This is a very poor practice, and if

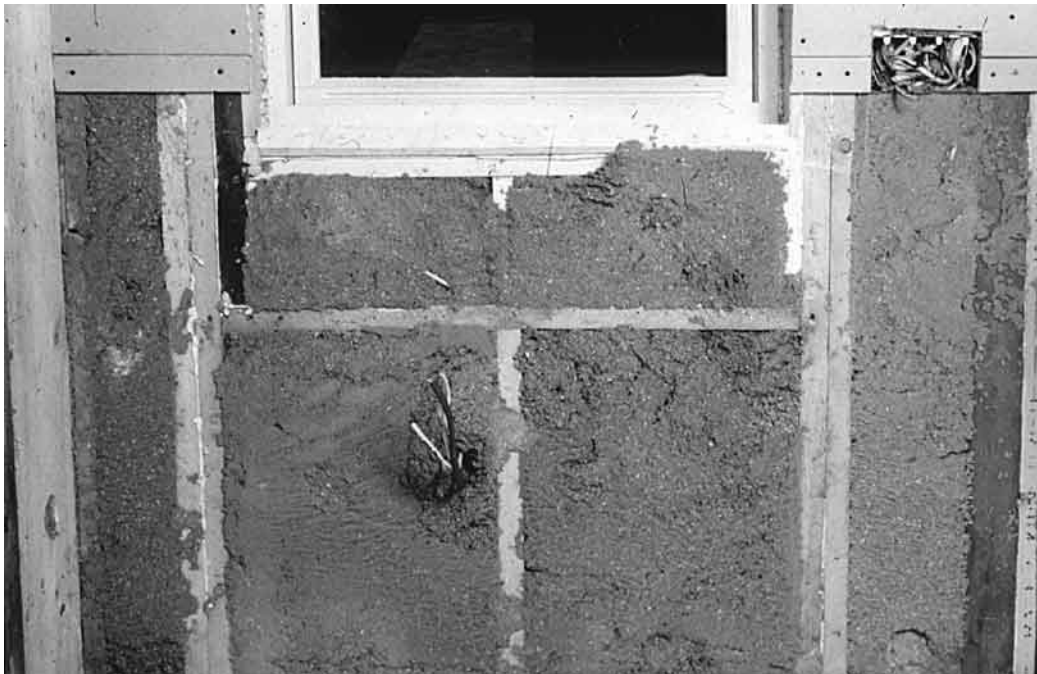
Figure 8: This demonstration wall was blown full of cellulose and then the interior sheathing was removed to inspect the result.

Insulating walls with dense-pack (DP) cellulose (*fig. 8*) has become the cornerstone of the weatherization industry, and is indispensable to the revitalization of old buildings. In dense-packed walls, the cellulose insulation is blown into the walls at higher densities than the industry standard. Cellulose insulation manufacturers recommend densities of approximately 2.7 pounds per square foot. However, when cellulose is pneumatically installed at high velocity to densities greater than 3.5 pounds per square foot, it acquires a unique air sealing property. In this process, the material behaves as a fluid, flowing into obscure bypasses and solidifying them. Dense-packing solves air movement problems critical to building performance that would be impractical to access or repair in any other way, especially in historically significant buildings, where retaining original interior and exterior wall surfaces is crucial.

Building cavities are dense-packed by inserting a pipe, tube, or hose down the entire length of the passage. A powerful insulation chopper and blower delivers a lean mixture of cellulose and air at about a hundred feet per second. Initially the cavity is pressurized with a cloud of insulation. The air flows out through every crack and pinhole carrying fine particles of insulation. The holes are clogged with insulation until they stop flowing and the cavity fills with a loose pile. Then the cellulose chunks charging down the tube start to slam into the loose pile and pack it. When it becomes very tight, it plugs the end of tube and stalls the insulation blower. The tube is quickly pulled back until

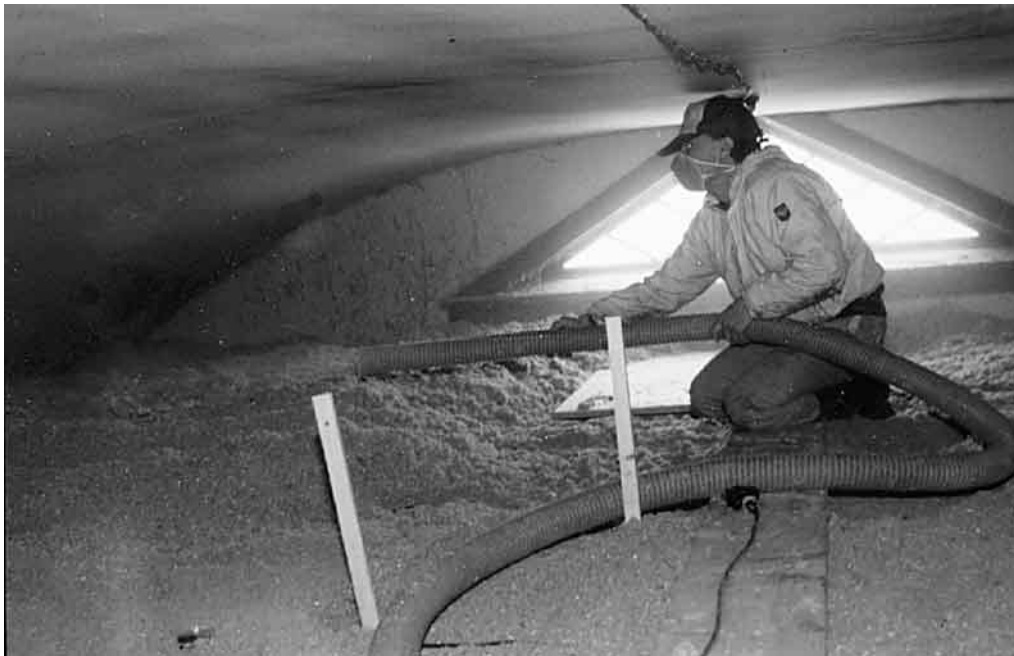
Figure 9: Blowing an attic crawl space. Cellulose does not have to be sandwiched between two surfaces as in a wall or under a attic floor.

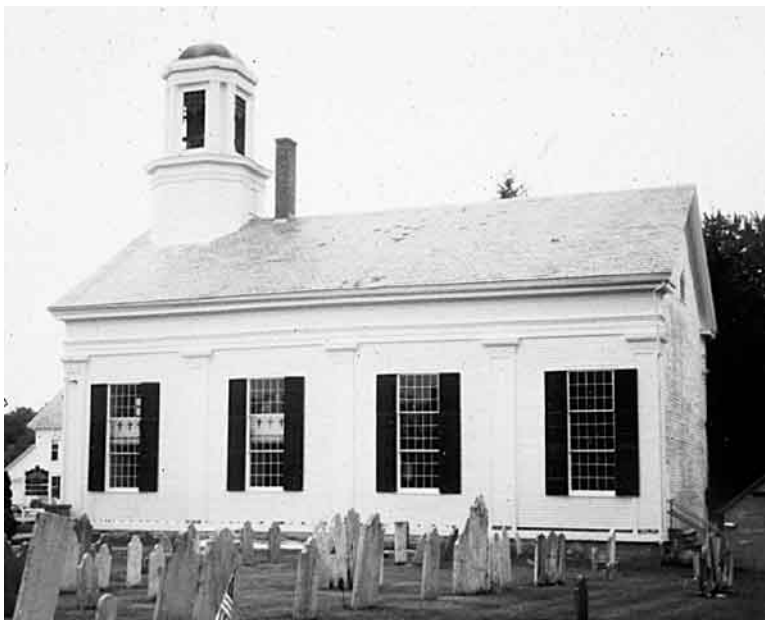
Figure 10. The Cornwall Congregational Church. The passive improvements made in this building had no effect on its appearance.

The Cornwall Congregational Church in Cornwall, VT (*fig. 10*), built in 1803, was a huge financial drain on its congregation. Heating the building for just one Sunday service in the winter burned through about 200 gallons of fuel oil. Needless to say, the building was all but useless during the coldest months. When a member of the congregation donated some money for repairs, they decided to do something about it. Most of the contractors called to give estimates focused on the windows, proposing to replace them or block them entirely, solutions that would have adversely affected the appearance of the building, even though studies show that windows are the least cost-effective place to go for energy savings. Usually the payback time is longer than the life of the replacement windows.

Instead, by concentrating on the minimally-insulated attic, leaky ducts and the walls' 14" deep cavities, the appearance of the building wasn't changed a bit. The building was air-sealed and duct-sealed, and over ten tons of cellulose was blown into the walls from the exterior and open blown into the attic. Air leakage was cut over 70% as measured by the blower door tests, and the heating bill was cut by two-thirds. Now the building is used year-round by its congregation, making it much more useful and vital to the community, rather than a problem white elephant destined to extinction.
