“There is a house that is no more a house” Conservation of the Painted Wall Paneling in Shelburne Museum’s Stencil House

Nancie Ravenel, Objects Conservator, Shelburne Museum

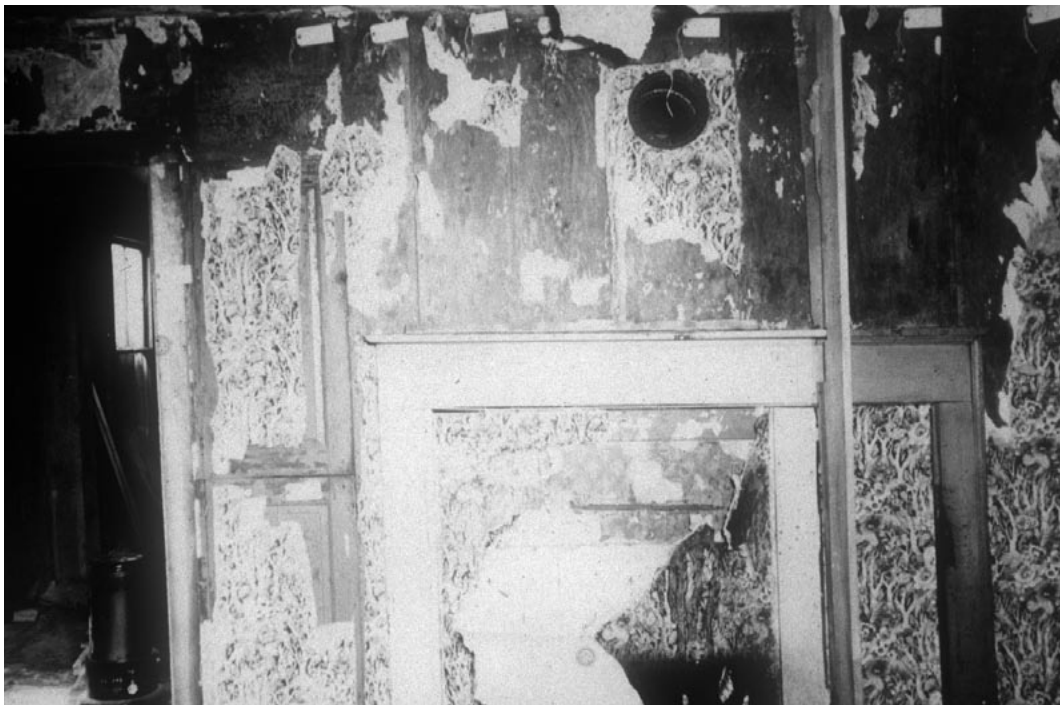
Figure 2. Stencil House dining room before disassembly in Columbus, NY, 1952.

When the painted wall paneling from the Stencil House came to Mrs. Webb's attention in 1952 it was covered by about five layers of wall paper (figs. 1 & 2). And rather than the house itself, it was really these painted walls that grabbed her interest. In a letter dated October 1952 to American Decorative Arts scholar Nina Fletcher Little, Mrs. Webb writes:

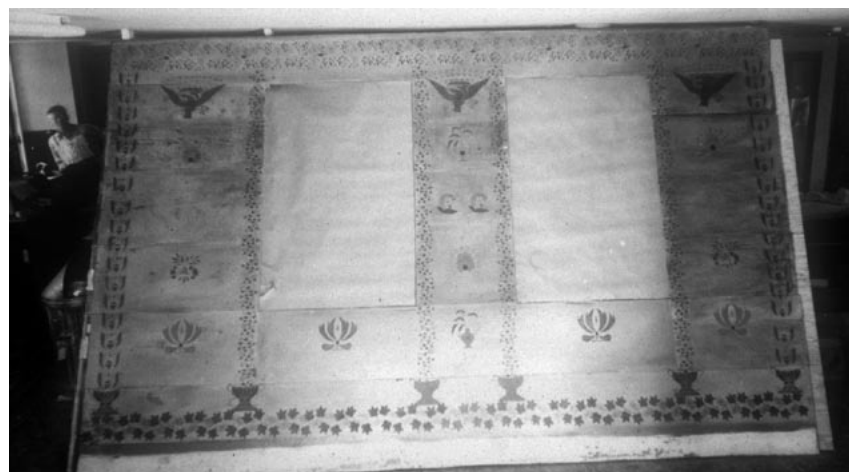
Figure 4. Wall, during treatment, with panel fills under the windows, circa 1954.

At some point while the house was in New York, the windows throughout the house were enlarged and the paneling was chopped out to accommodate the larger windows. The windows currently in the house are smaller than they were when the house was acquired, so he had to add new boards under the windows in his reconstruction (fig. 4). He also had to add new boards to the parlor and front hallway to accommodate the changes in the floor plan that Mrs. Webb desired. For example, with the exception of the boards under the windows, the three walls other than the fireplace wall were in original paint. The fireplace wall is unusual because so many panels were completely added.
