Treatment Protocol for a 1929 Phantom I Wood Body Rolls-Royce Automobile

Mark Anderson & Gregory Landrey

ABSTRACT

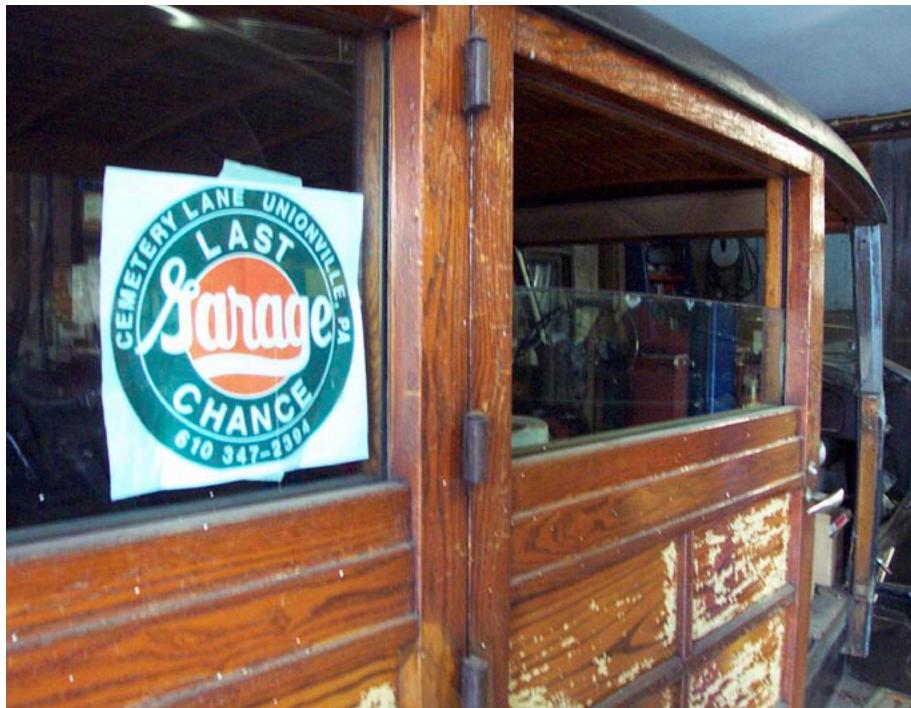
Figure 2. Ash coachwork.

The coachwork is constructed entirely of ash (*Fraxinus* spp.) utilizing the wood for the thick structural floor elements, the interior trim and roof boards and the joined frame and panel construction. In several instances the wood is covered by protective overlays including faux wood grain-painted aluminum panels exhibited on the exterior of the coach-body and the wooden roof structure which is covered by a sealed textile roof canvas marketed under the name Neverleek. The construction of the coachwork utilizes mostly

open bridle style joinery which is augmented by mechanical fasteners. The “open finger” system of joinery is slipping and separating in many areas of the doors and coachwork structure.

While setting a rustic tone and creating a warm feeling, the wooden body parts have yielded to rot and decay in some areas of the coachwork and require restoration. Ash has only moderate resistance to rot and decay but coach builders often chose it for its high strength to weight ratio, for its easy machining and for its ability to take and hold stain and varnish. The joined wooden coachwork from the Brewster shops, while of high quality is certainly the product of a “modern” commercial technology, employing power shaping and sawing and mechanical fastening systems. (fig. 2).

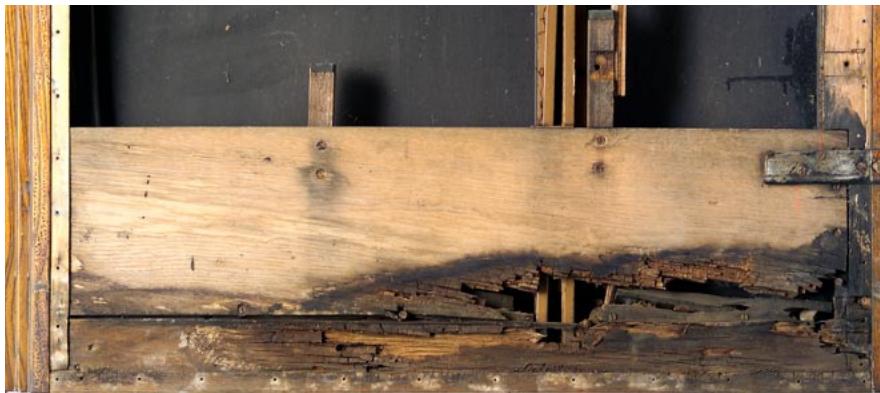
Figure 3. Degraded wood, interior of door.

The interior aspects of construction reveal degradation that is the result of trapped moisture combined with the relatively decay-prone timber. (fig. 3). This deterioration is the result of design and material failure built into the original construction. Unlike today’s rubber window seals this Rolls-Royce makes use of a woolen felt weather-strip at the interface of the window sill area and the crank down window. While making for a quiet and easy descent of the window glass, the felt seal has allowed water to collect in the interior areas of the lower door. The vertical metal track lined with felt helps guide the lowering of both the small triangular vent window and the larger side window. With the deterioration of the felt the track has also acted as a rain spout, channeling water down

and into the lower areas of wooden door framing.

In some areas the rot has extended into the hinge stiles causing weakness in the door-to-frame attachments as in a heavily deteriorated area above the hinge. These losses will require inserting new structural wood elements.

It is our recommendation to consolidate as much of the existing rotted material as possible and add new spliced or patched wood elements only as necessary. Because the car is intended to be used, the repairs must be strong and field serviceable and will require mechanical fasteners as needed. This more active approach differs from the very passive way most furniture conservators would treat a fine joined wooden object. As in furniture conservation though, we recommend that any added wood elements be sympathetic to the original grain, color and porosity of the original timber and any finish variances between old and new should not be immediately obvious. Previous repairs meet some but not all of these criteria.

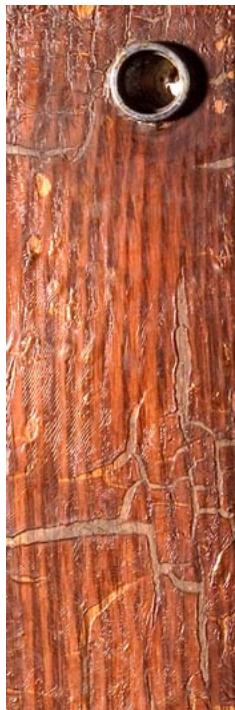
Figure 4. Degraded varnish on the exterior coachwork.

We have noted the quality of the existing top varnish coat on the Suburban body examined for this study is less than superior and Valentine's provides information on this topic as well in their publications of the period (Varnish Difficulties). In fact most of the pitfalls warned against in the Valentine's literature are evident on the current topcoat of varnish on this Phantom I. (fig. 4)

It seems likely that the vehicle will be driven and exposed to the elements, even if infrequently, increasing the need for a protective top coat over the existing varnish. This is where our colleagues who deal with large scale exterior projects may be helpful in selecting a coating that would be as reversible as possible and aesthetically pleasing while protecting the original varnish and wood from the elements.

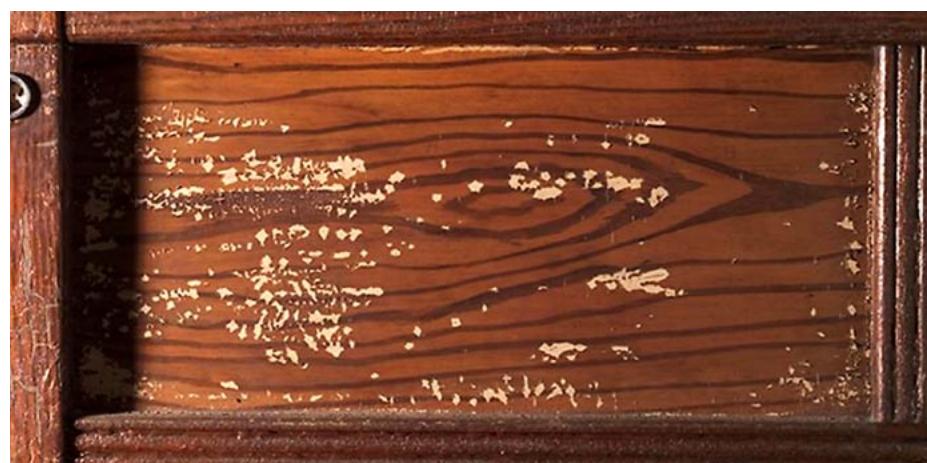
Figure 5. Grained paint on aluminum substrate.

Paint on metal: The exterior door panels are grained painted on aluminum which is particularly fragile. Flakes seem to pop from the surface with energy all their own. (fig. 5) The other non-wood components of the body, fenders, hood and cowl are painted black. There is some separation but little corrosion.

The treatment options for the grained paint are varied. It does seem reasonable, even if not easily reversible, to consolidate this grain painting using a weather resistant material. Possibilities for consolidants need to be researched and explored to select

a material with proper glass transition point, UV stability and colorfastness. Acrylic resins are materials that may meet these criteria and are common to the conservation profession.

Areas of loss could then be inpainted to blend visually. While such a treatment might not win this vehicle 100 points in a competitive concourse exhibit, the skills common to a decorated surface conservator could bring the aesthetic to a point that the grandeur of the vehicle could be brought back while retaining the originality of the unknown Brewster artist who rendered this faux surface in 1935. Another approach would be to create a precise reproduction of each of the panels and retain the originals either in place behind the reproductions or in secure storage.

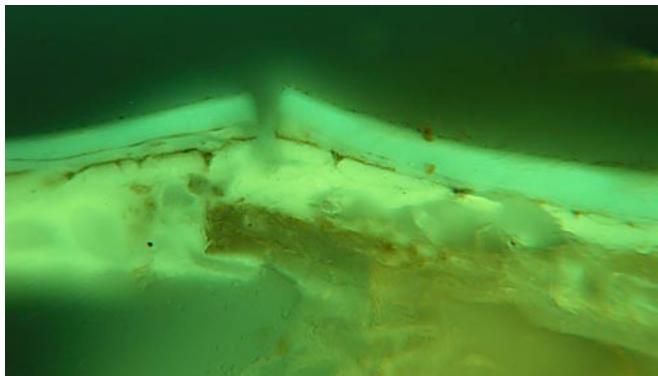
Figure 6. Cross section, exterior varnish, UV light, Leitz D filter cube.

Varnish on Wood: A cross-section was taken from the front passenger's exterior wood door frame member and viewed in ultra-violet light using the

Leitz D filter cube. The image indicates the presence of two zones of a transparent coating. (fig. 6). Note the weathered characteristic of the first, lower layer in figure 6, which could well be the varnish applied by Brewster in 1935. A second, upper layer covers the earlier weathered surface. This second coating most likely dates no later than 1950, the year Mr. Ferguson purchased the vehicle, since the oral history indicates that nothing has been done to the wood body since that time. The fluorescence emission of the two layers suggests that the properties of the two coatings may be sufficiently different that they could be separated, but this is just speculation at this point. Additional layer-by-layer analysis may help identify specific characteristics that could be taken advantage of should selective cleaning be desired.

Analysis with FTIR indicated that the top coating seen in this section was primarily an alkyd resin and oil, possibly tung oil and GC-MS confirmed these findings. Additional analysis is needed to determine the composition of the lower layer. A spot test of the outer surface indicated that the varnish softened readily with ethanol. This may be in contrast to the experience of some, that alkyds are resistant to such polar solvents. However, alkyds are vulnerable to a degree to alcohols and this may be good news if the owner wishes to selectively remove just the later layer.

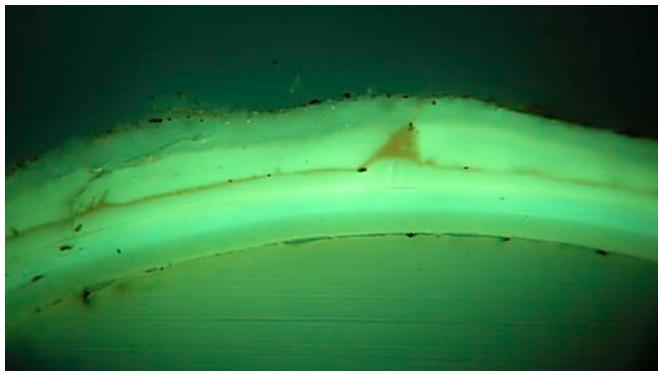
Figure 7. Cross section, UV light, grained paint.

Grained Paint on Metal: A sample of the grained paint was analyzed using scanning electron microscopy-energy dispersive spectroscopy (SEM-EDS). A variety of elements were found in the base layer of the grained paint including silicon, aluminum, sulfur, barium, calcium, and zinc. (Carlson, Mass, Matsen, Petersen, 2005). A cross-section of a cupped grained paint sample shows the layering of the semi-transparent varnishes used to create the grained effect as well as the complexity of this coating. (fig. 7).

FTIR and SEM-EDS analysis indicates that the grain painting is a combination of cellulose nitrate, fillers, phenolic resins and oils. (Carlson, Mass, Matsen, Petersen, 2005). To summarize the grained painting analysis, the faux surface was achieved by using a white base of kaolinite and barium sulfate in a cellulose nitrate binder with the grained effect produced by using sparsely dispersed pigments in a phenolic resin and tung oil binder.

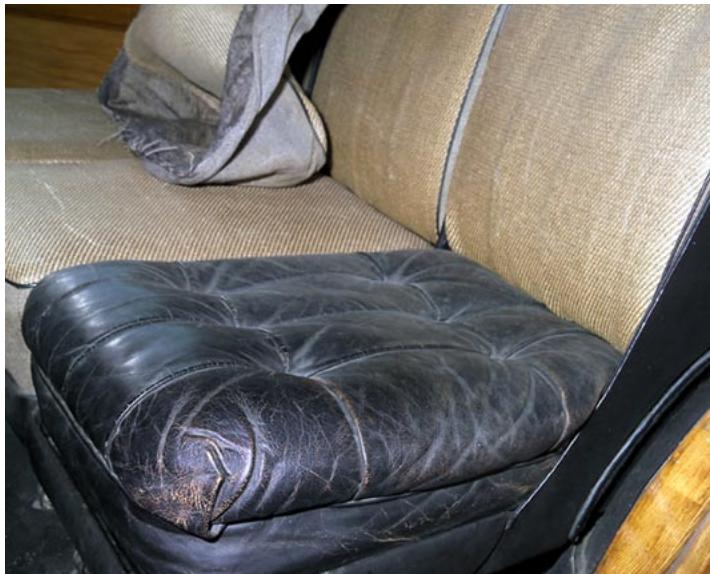
Figure 8. Seat cushion.

The interior upholstery of the Phantom I appears to be well preserved. (fig. 8). The primary upholstery material for the seats is leather, but durable faux rattan slipcovers have been made for each of the self-contained seat units. At first we thought the cases covering the leather upholstery were contemporary to the 1934 body but upon further study they now seem to be associated with the Split Rock Lodge Period and were nailed over the leather to protect it while the car was used as a jitney.

The upholstery under the faux rattan case is a standard panel and buttoned leather cover common to the 19th and early 20th centuries. There are dissimilar aging qualities on the outer edge of the seat. A student working on the project was the first to observe this wear and minor deterioration which is localized to the three outer panels (Yoshizawa, 2005). This is illustrated quite clearly by the sharp area of degradation transferred to the paper rattan on the underside of the top case which is acting as a useful, yet unfortunate, litmus test.

Obviously, a different batch of leather was cut to make the outer panels and it is not known how much more of this grade material exists on the other seats. For the time being the degradation is not at all severe, even though the car is kept in totally uncontrolled storage.

It is recommended that the rattan covers be kept in place as they do serve to protect the original leather seats. The covers could also be removed and preserved separately following routine conservation guidelines (Landrey et al, 2000). Binding and consolidation of piping areas on the interior upholstery is recommended along with standard cleaning procedures. The boot (trunk) compartment should not be used for the current collection of tools and jumper cables that it holds.
