A Study of the Materials and Environment at Russel Wright's Dragon Rock

Susan L. Buck, Conservator, SPNEA Conservation Center

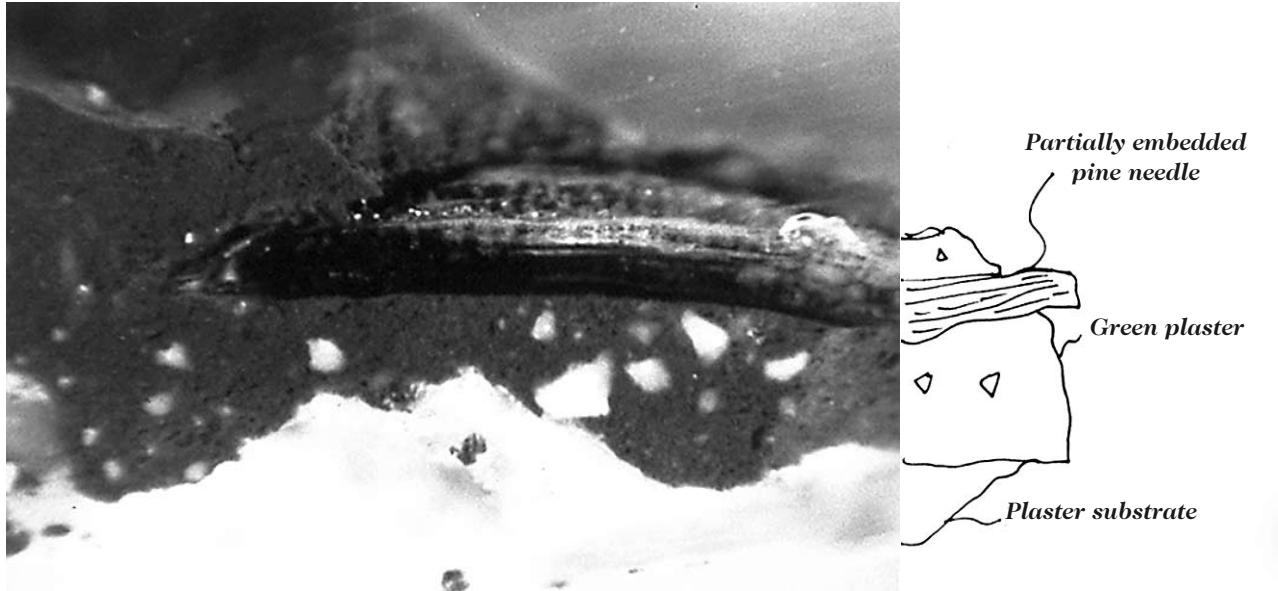
One sample was taken from an area of efflorescence on the west wall where salts have been deposited on the surface by water wicking out through the plaster substrate and the textured green plaster. This water carries soluble salts from the plaster which then dry on the surface leaving a powdery white deposit. The plaster substrate and the green plaster finish layers are particularly friable in this area.

1. Investigate and correct the sources of moisture traveling through the living room green plaster and the stucco-like paint in the hall.
2. Determine the best methods for shielding the most vulnerable areas of the house and studio from excessive visible and UV light exposure. Install UV blocking materials as soon as feasible, and install light-reducing shades where possible.

3. After the moisture problems in the walls have been identified, test alternative methods for consolidation of the flaking plaster and peeling stucco-like paint in the living room and hallways.
